PRACTICAL PLANT FAILURE ANALYSIS

A Guide to Understanding Machinery Deterioration
and Improving Equipment Reliability

Neville W. Sachs, P.E.

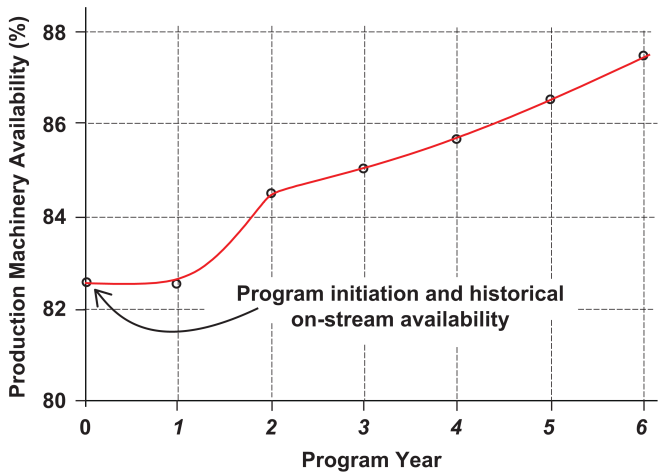
FIGURE 1.2 The effect of a formal reliability/failure analysis program. (After this, availability continued to increase but there were site changes that make later data inaccurate.)

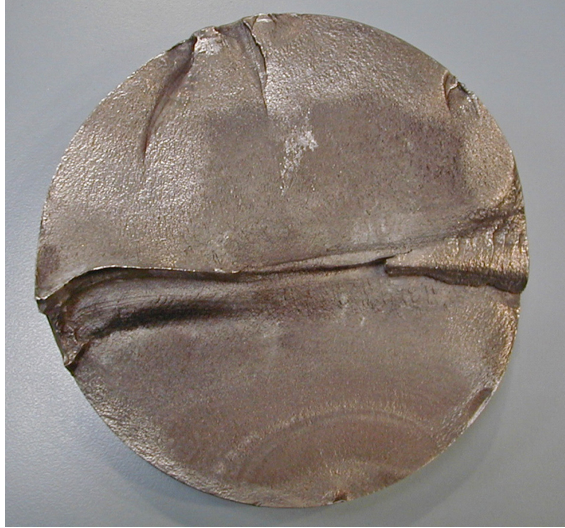
Inspection of the failed agitator shaft shown in Photo 2.1 indicates that it was a fatigue failure, was primarily caused by two-way plain bending, had stress concentrations, and was lightly loaded. Further inspection of the shaft exterior surface will find evidence of the faulty maintenance practices that caused the two-way bending.

PHOTO 2.1 An agitator shaft fatigue failure.

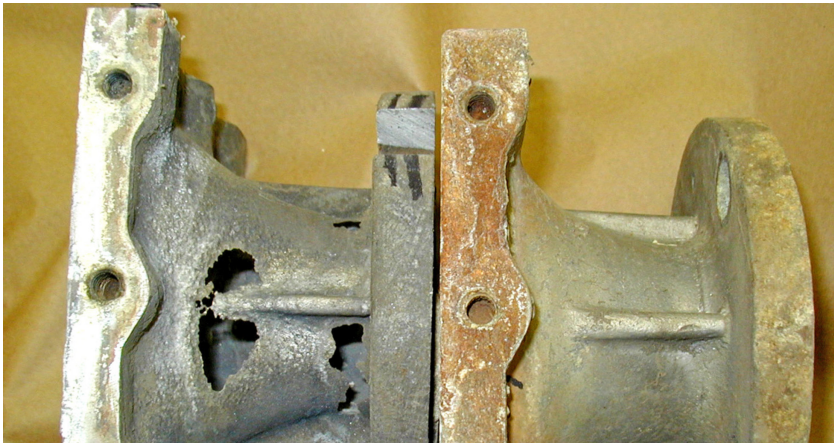
PHOTO 2.2 Pitting corrosion from elevated temperatures on an aluminum housing.

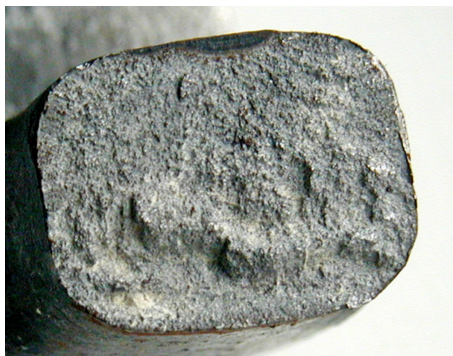
PHOTO 2.3 A chain link that has failed as a result of an overload. Note that the small dark area at the top of the photo was a crack that existed well before the catastrophic failure.

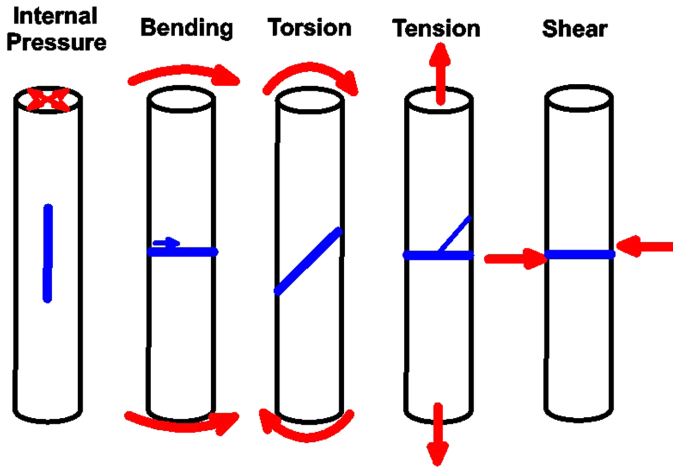
FIGURE 3.3 Except for pure shear, the fracture plane is always perpendicular to the force (the stress) that caused it.

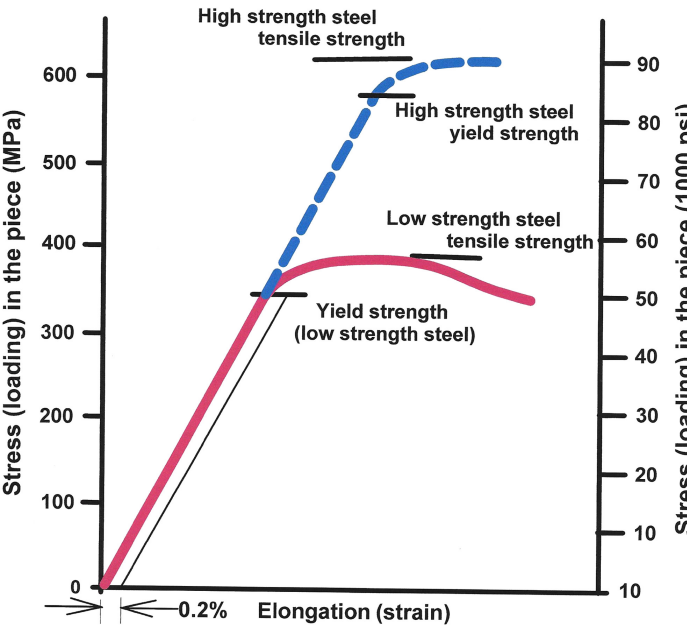
FIGURE 3.4 A typical stress-strain diagram showing how much a part distorts with a given load (stress).

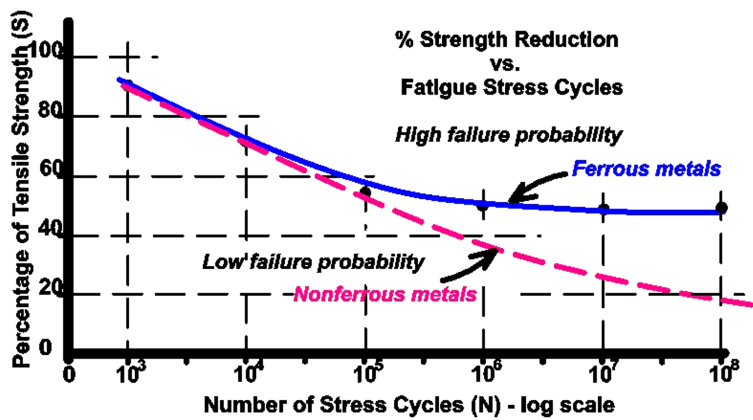
FIGURE 3.9 An S-N diagram showing how the fatigue strength of a metal varies with the number of stress cycles.

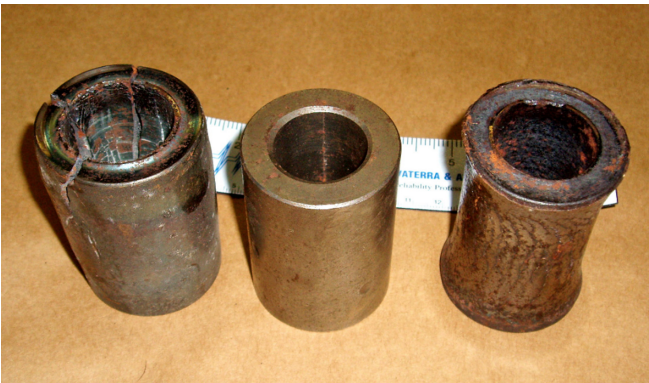
PHOTO 4.1 Three conveyor rollers. On the left is a case hardened piece with a series of brittle fractures. The center one is unused, and the unhardened one on the right shows the effect of a ductile overload.

elevators and they function very much like the rollers in a common roller chain. The center piece is as they were supplied and the pieces on either side were from different production batches but used in the same application. (They both should have been case hardened with a relatively thick case, but the supplier made an error.) The one on the left was hardened and has fractured longitudinally in several places while the unhardened one to the right has tremendous ductile deformation. Identical compressive loads with very different failure appearances because one was brittle and the other ductile.

An example of that difference in appearance can be seen in the identically loaded parts shown in Photo 4.1. These are three chain rollers used in industrial bucket

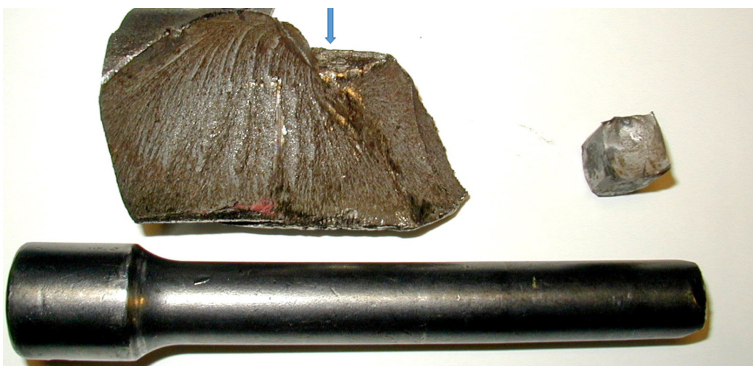
Photo 4.2 is an example showing two torsional overload failures and the very obvious difference between ductile and brittle materials. The piece on the upper left is from a hardened utility truck axle, and this brittle fracture occurred only a few thousand miles after the truck was delivered. The cracking started at the large metallurgical defect shown by the arrow and then propagated at a 45° angle to the central axis. Below it and to the right are two pieces from the ductile overload failure of an inexpensive 1/2" socket wrench extension and the end has been smoothly turned off.

PHOTO 4.2 Two torsional overload failures with the brittle fracture in the upper left and the two pieces of a ductile overload failure.

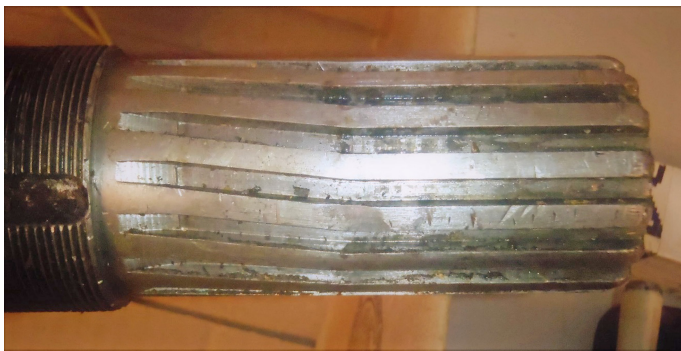
The spline shown in Photo 4.3 is a bit of an uncommon example because it didn't occur as the result of a single blow. The yield strength of a metal is generally defined as occurring when the plastic deformation exceeds 0.2%. But this shows what eventually happens when a load that causes a 0.01% or a 0.005% deformation is applied many, many times.

PHOTO 4.3 The ductile deformation of the input spline on a small reducer.

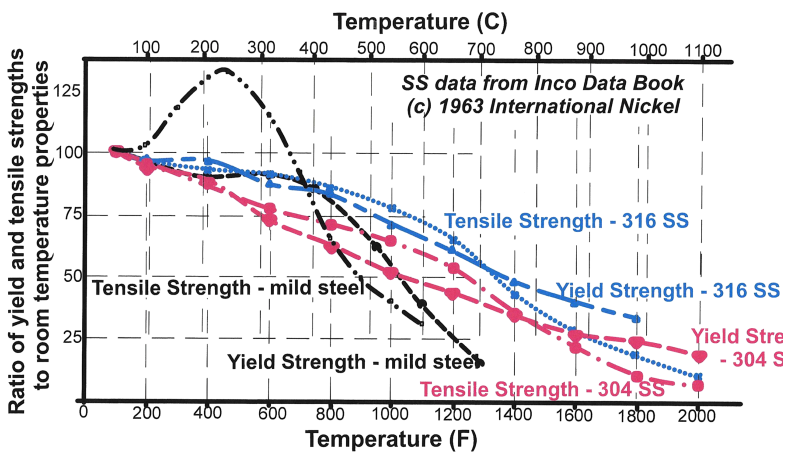
FIGURE 4.2 The temperature effect on tensile and yield strengths of mild steel and two stainless steel alloys.

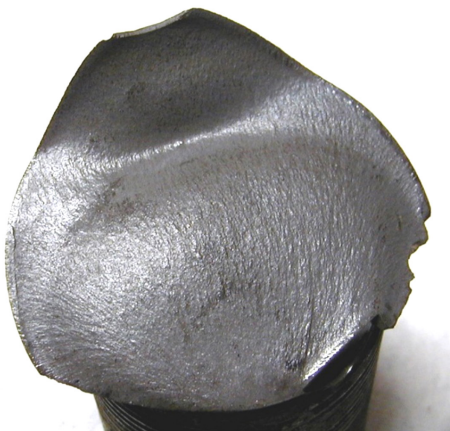
Photo 4.9 shows the brittle fracture of a large reducer input shaft that was caused by an impact load when the shaft was bumped. The “chevron marks”, the lines on the fracture surface, are a great aid in the diagnosis of brittle fractures because they point to where the failure started. An interesting point is that most persons would expect the fracture to begin at the keyway notch, but the actual origin is just to the left of it.

PHOTO 4.9 The brittle fracture of a reducer shaft with “chevron marks”, lines on the surface of the fracture, pointing toward the crack origin.

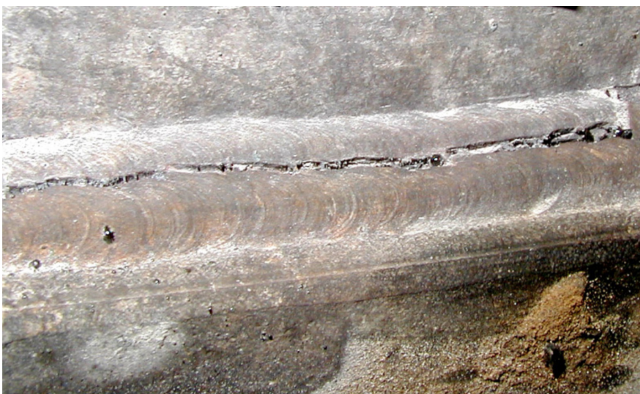
PHOTO 4.14 The brittle fracture of a ductile weld material because it was so constrained that ductile elongation wasn't possible.

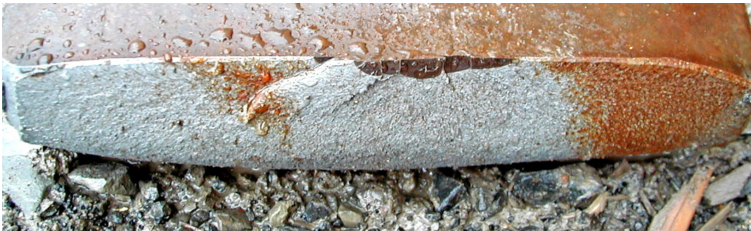
PHOTO 4.16 The brittle fracture of a fork off of a lift truck with an older cracked area in the top center that created a stress concentration.

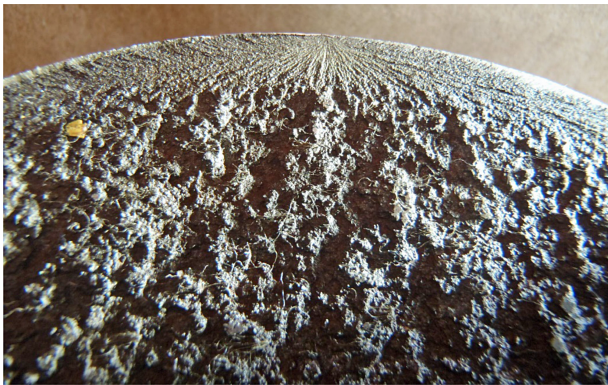
The photos show a 130 mm (5") diameter pin used as a pivot in the boom of a very large bucket loader used in a production operation. The pin had an HRC 60 hardened outer layer about 3 mm (1/8") thick while the core was about HRC 20. Photo 4.17 shows the origin while the lighting has been changed in Photo 4.18 to emphasize several earlier cracks. Inspecting the fracture face shows that:

- The hardened case fracture surface is much smoother than the core (because it has a finer grain structure).
- The early smaller cracks were from impacts that didn't have enough energy to propagate through the entire case.
- Using low magnification, about 7X, and low angle lighting, the chevron marks in the case can be easily seen.
- The propagation marks continue through the unhardened core but are much coarser.

PHOTO 4.17 A close up showing the chevron marks in the hardened case.

From the existence of those small earlier cracks we can tell that the impact load that caused the failure wasn't an isolated event. (Further investigation found that the bucket loader operator occasionally ran into some of the building structure!)

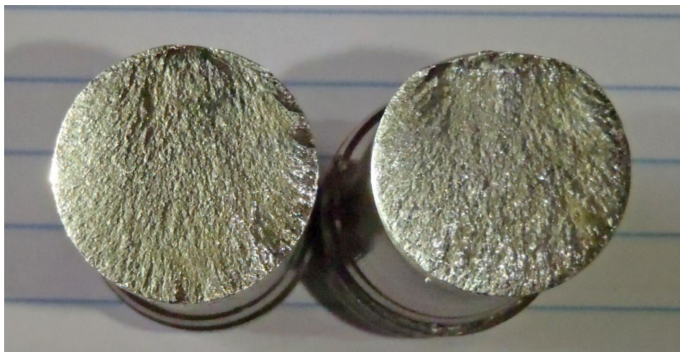
PHOTO 4.19 Two very ductile stainless steel bolts that were grossly overloaded and fractured in a brittle manner.

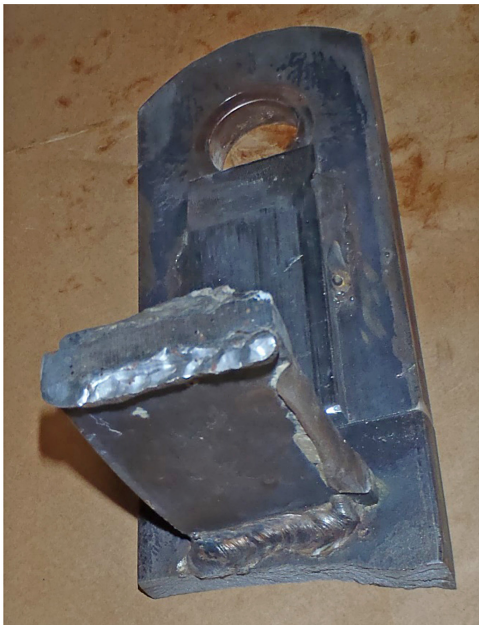
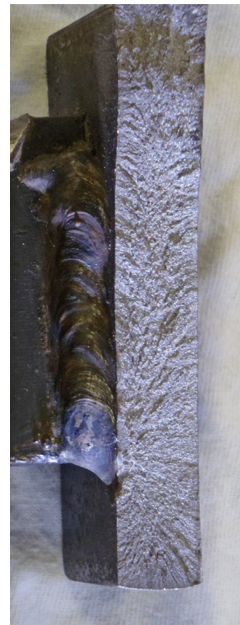
So they decided to weld some cross supports between the side links to prevent them from coming apart. Photo 4.20 shows a broken link with the battered welded cross support. Photo 4.21 shows a view of the fractured link and looking at it we can clearly see the chevron marks that point to the origin and the hardened nugget at the toe of the weld.

What happened was that the side link was SAE 1045 steel and, with 0.45% carbon, was easily hardened. But they didn’t preheat the side link before welding and the mass of the part quenched the toe of the weld creating a hardened area that had expanded in volume, creating an internal stress in the part. Then, when the abnormal operating stresses were applied the link snapped.

PHOTOS 4.20 AND 4.21 On the left is the broken chain with the welded cross support that the plant had added. (Note that the weld on the end of the support has been deformed in a ductile manner.) On the right is the brittle fracture of the side link with obvious chevron marks pointing to the origin at the weld toe.

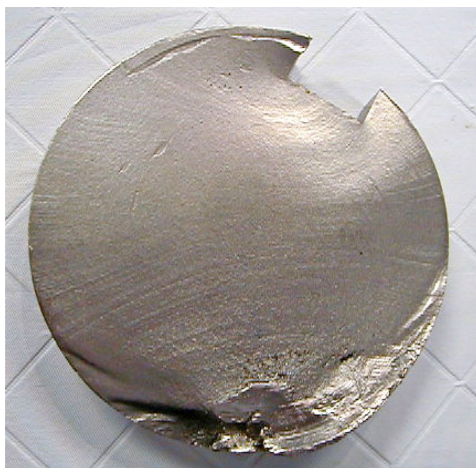
PHOTO 5.3 A fatigue failure with clearly defined origin at the corner of the keyway and asymmetrical progression marks that grow unequally across the fracture face.

3. The shaft was rotating in a clockwise direction.
4. The many progression marks show that there were a large number of changes in the shaft stress.
5. At the time of final failure, the shaft stress was very light.

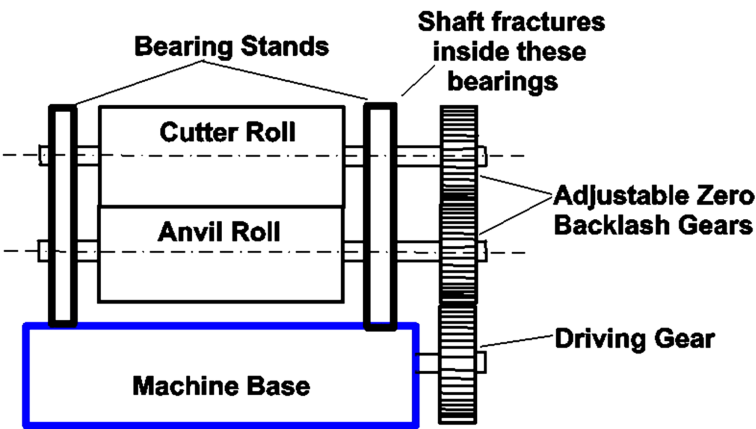
FIGURE 5.8 The plant had several of these machines and had broken six shafts inside the right bearing housing. Then analysis of the fracture face showed the primary cause of the failures was the stress from improperly adjusted zero backlash gears.

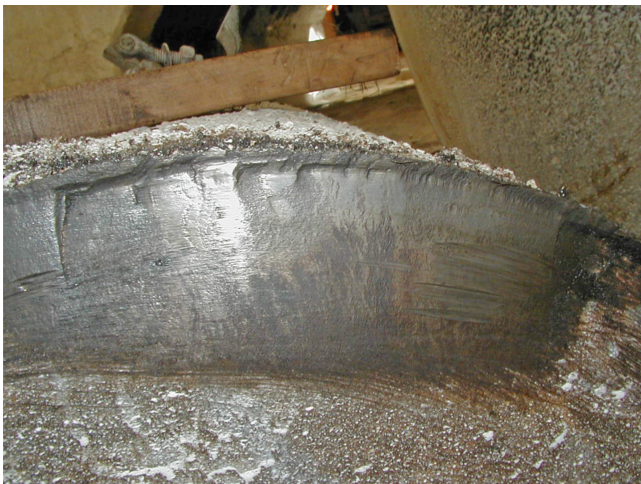
PHOTO 5.6 This shows the OD of a large kiln trunnion shaft that has been built up by welding. The white material toward the top of the photo is some debris and just below that is a layer of weld metal.

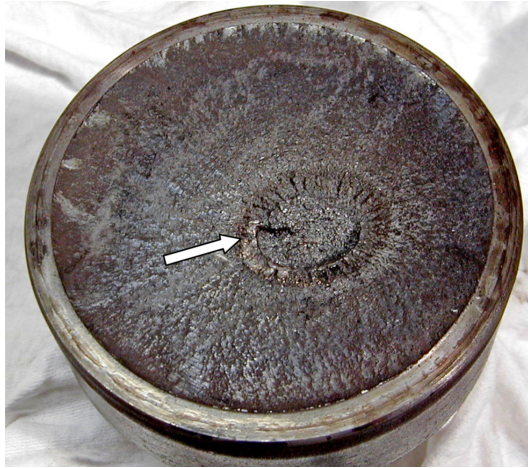
PHOTO 5.7 This is an example of a rotating bending failure with many origins, no progression marks, and a light final load. (A careful observer will also notice that the shaft shows evidence of a weld repair. However, the major problem was a razor-sharp radius at the step in the shaft.)

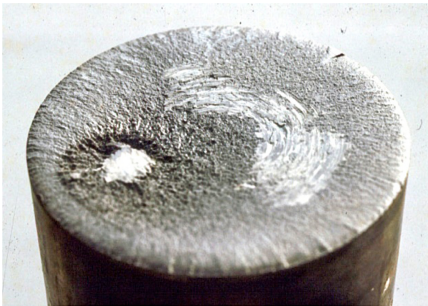
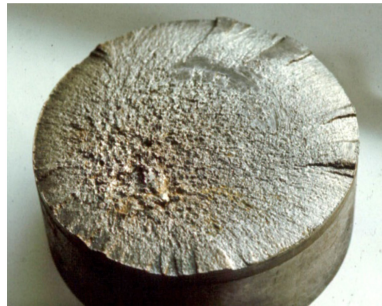
Photos 5.8 and 5.9 show two shafts that came off the same 900 rpm motor installation. The first one ran for 24 hours while the second one lasted only 12 hours.

PHOTOS 5.8 AND 5.9 Two 100 mm (4") shafts off the same 200 hp motor location, with the left one lasting 24 hours (1.25 million revolutions) and the right one less than 12 hours (600,000 revolutions).

Comparing them we can see the difference between the field stress level on the shaft and the effect of stress concentrations.

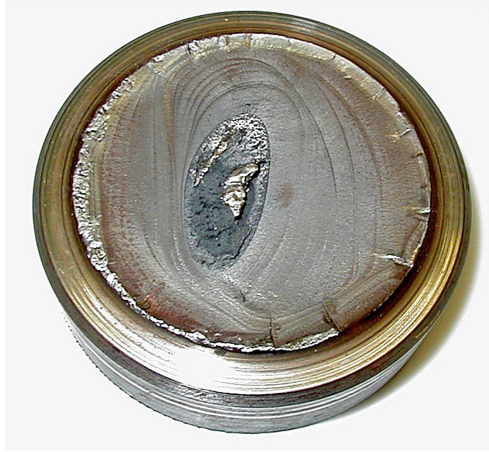
PHOTO 5.11 This shaft tells an amazing amount of information about the causes. We see lots of ratchet marks, lots of progression marks, and an IZ that says the final force was a combination of rotating and plain bending. Also, the progression marks echo that.

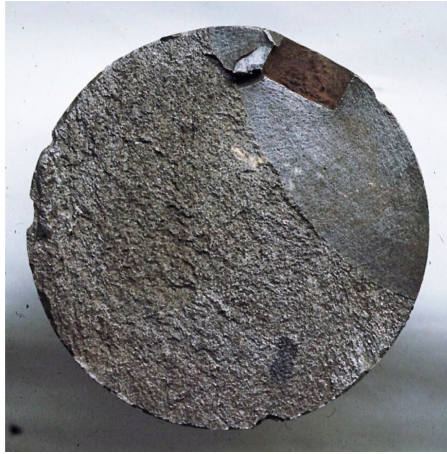
PHOTO EX5.17

This was the input shaft for a reducer on a small kiln drive. It was found to have failed at the end of the coupling when they went to start the kiln after a winter maintenance day.

1. The change in roughness, from the very smooth to the very rough, tells that it was a fatigue failure.
2. There is some corrosion on the keyway.

3. The main FZ is flat across the shaft and but it's growing eccentrically and that says it was from rotating bending fatigue.
4. The progression marks lead back to the upper right side of the keyway, a common stress concentration.
5. The arrow points to a second fatigue crack that's caused by torsion and it starts at the bottom of the keyway.
6. The IZ is huge and presents a conflict because we have a very smooth fatigue zone which would indicate an old and slow-growing crack, the result of a relatively light load. Yet we have an IZ that says there was a tremendous load.

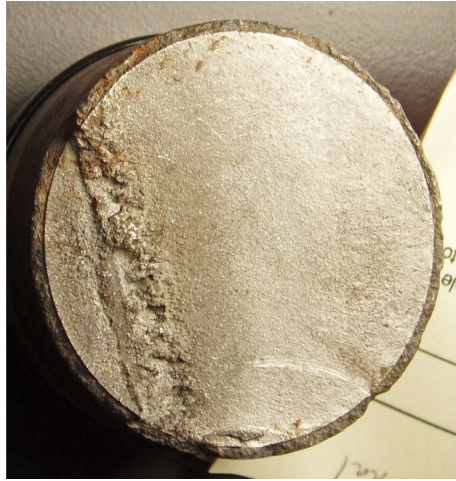
PHOTO EX5.18

This was a shaft off a paper machine and the initial diagnosis is pretty straightforward.

1. It is a primarily a plain bending fatigue failure because the crack seems to grow pretty straight cross the face. There is a faint progression mark (at the broken line) about one-fourth of the way across and it is relatively straight, but not quite parallel to the IZ.

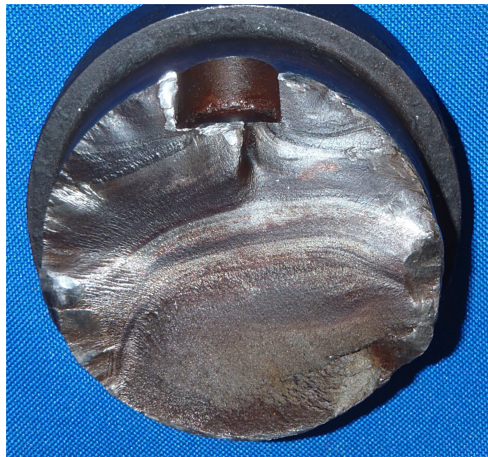
PHOTO EX5.19

Conclusions and recommendations – The very smooth fracture face tells us that shaft has been cracked for a while and the IZ tells that it was heavily loaded, but the really interesting point is that there is asymmetrical cracking on both sides of the keyway, yet the machine always drives in one direction.

Although the major drive force was in the CCW direction, we see that the failure resulted from cracks on both sides of the keyway and was most likely caused by the “hunting” of the drive motor trying to repeatedly accelerate and decelerate the pinion.

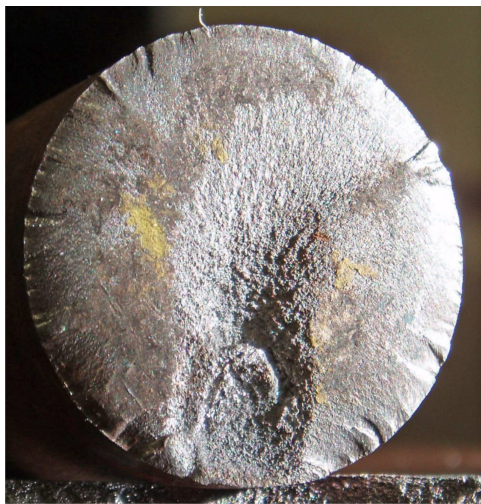
PHOTO EX5.20

- If it was just rotating bending, the expected chain load, the IZ should be round.
- But this IZ is the result of a combination of rotating and plain bending loads and the combination is excessive.

Solving what's really happening requires a physical inspection of the chain drive shaft and sprocket, but something is physically wrong. Either this sprocket or the driven sprocket, or the mounting shafts are seriously eccentric.

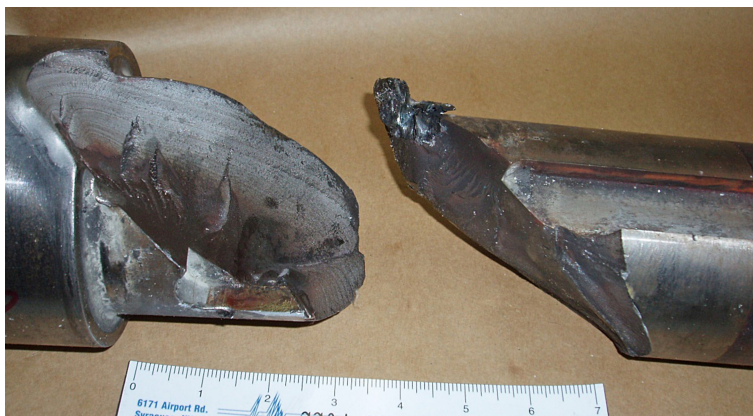
PHOTO 6.1 The torsional failure of a machine shaft showing the classical 45° fracture face. The cracks started at the key seat and the last few progression marks before the final failure can be seen in the left portion.

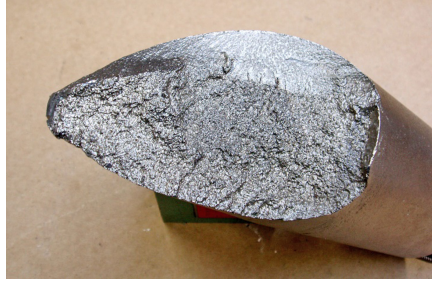
PHOTO 6.2 Another torsional failure, again with the major fracture plane on a 45° angle.

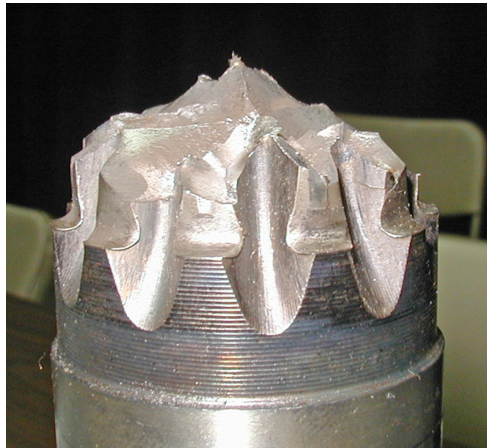
If there had been a serious stress concentration on that shaft, the fracture would have developed in several locations almost simultaneously as shown in Photo 6.3. The cracks on this reducer input shaft developed on several of the splines and the failed piece looks almost like a star drill.

PHOTO 6.3 Another pure torsional failure, but this one has multiple origins and multiple fracture planes resulting in the cone shape. There is some bending but it is small compared to the torsional stress. If there were more bending involved, the angle of the cone would be less, i.e., flatter.

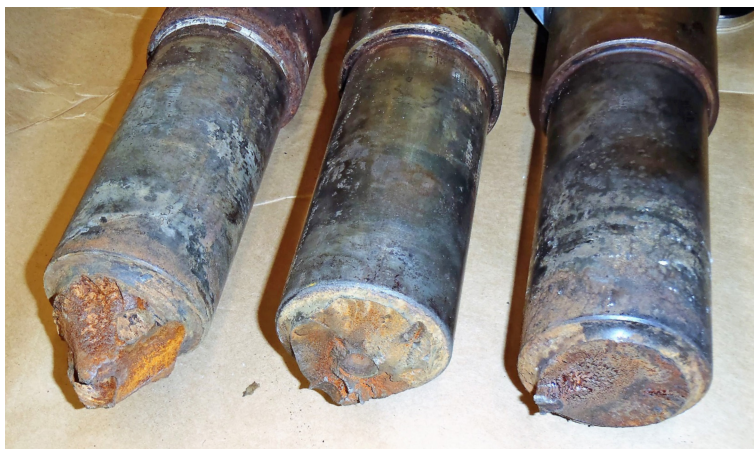
PHOTO 6.5 This shows three shafts from one pump house! The one on the left failed from pure torsional fatigue, the one on the right failed from pure bending fatigue and the one in the middle is a combination.

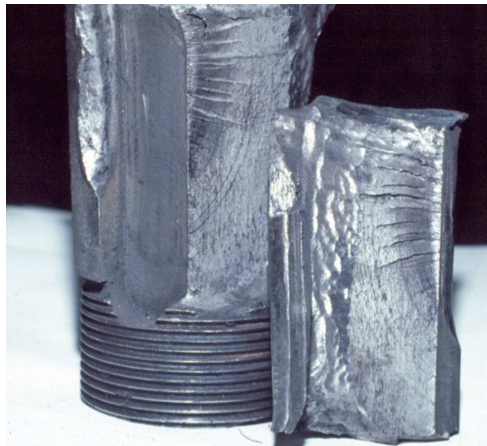
In the examples above, the failures were caused by loads that were applied along the length of the shaft. An even more common location for torsional fatigue failures starts with the stress concentration at the root of a key seat. In a device that is driven by a key, the driving force is applied across the center of that key and, if there is a typically small radius at the bottom of the key seat, the resultant fatigue stress can be substantial. Both Photos 6.6 and 6.7 show the evidence of torsional fatigue cracking and in both cases loose coupling fits contributed to the failures.

PHOTO 6.7 is the tapered fit coupling end of a large pump. In both cases there was a stress concentration at the bottom of the keyway but, again in both cases, sloppy assembly practices and loose coupling fits contributed substantially to the failures.

One of the problems with loose coupling fits is that the looseness results in fretting and fretting continually reduces the fatigue strength of the shaft material. Eventually the strength drops to the point where a fracture begins. Many mechanics don't like to install couplings with either interference or Loctited™ fits because it entails more work, but the benefit is that the chance for fretting is eliminated and the equipment lasts longer.

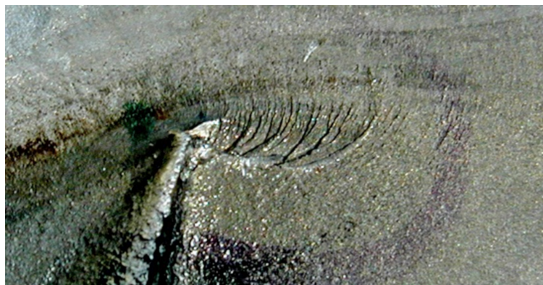
PHOTO 6.8 Shows river marks on the face a fatigue failure.

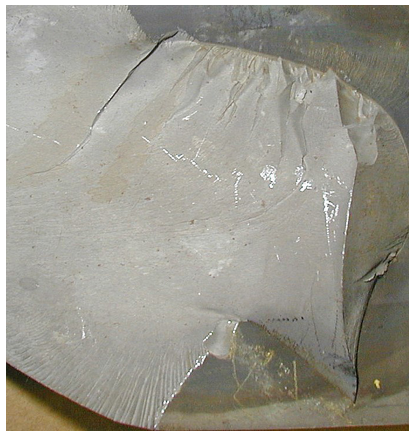
PHOTO 6.9 Shows two sets of river marks on the surface of a brittle fracture. This was a large broach that failed due to internal stresses. The river marks show how the cracks grew across the faces.

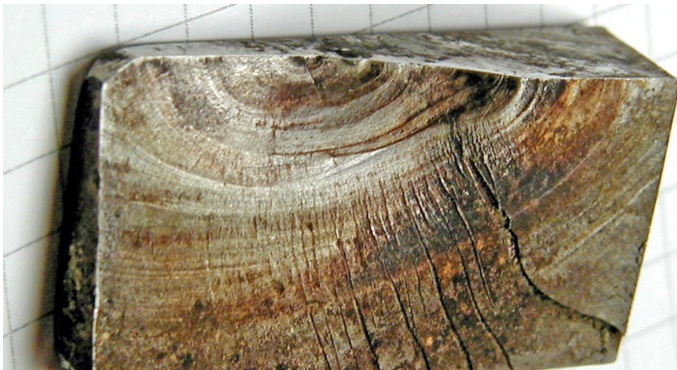
PHOTO 6.10 A thick stainless steel bar showing a fatigue failure. Across the face are an easily identified FZ, several very clear progression marks, and a host of river marks that show exactly how the cracking progressed.

There is a common lament from those folks that don't understand the basics of failure analysis; they want a catalog to show precisely "How to diagnose xxx" with a photo of the exact failure. What they don't understand is that most failure analysis isn't complicated and diagnosing a plate failure, such as that in Photo 6.10, is essentially the same as the diagnosis of any other fatigue cracking.

This is a 50 mm (2") thick piece of stainless steel is from a large food product plant and looking at it we see:

1. The progression marks and increasing surface roughness show it is a fatigue failure and took place over some time.

2. The force that caused the failure is either tension or plain bending and, because the progression marks grow symmetrically for the first half inch (25 mm), it was well centered on the origin.
3. The progression marks show there were a great many load changes during the crack growth.
4. The river marks show the fracture grew from the origin in the center generally toward the lower right showing that as the crack grew larger the force tended to grow a little more off center.
5. The small IZ in the lower right corner shows the part was not heavily loaded.
6. An inspection of the surface at the origin shows the crack started at the base of a fretted pit, reiterating the message in the paragraphs above about the problems fretting causes.

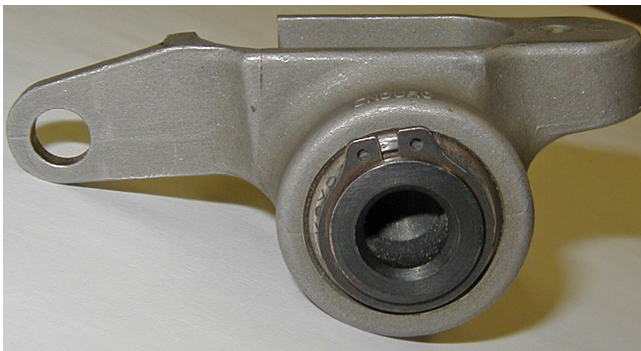
PHOTO 6.12 A fatigue crack in an area that should only see compressive stresses and the result of a heat treating error.

One of the cardinal rules of analyzing a failure is that the crack always grows perpendicular to the plane of the maximum stress and an example of how residual stress can contribute to a failure is shown in Photo 6.12. This is a rocker arm out of a racing engine that has a pair of fatigue cracks in it above and to the left of the bore. During normal operation the cracked area of the rocker arm should never see any tensile stresses, i.e., the push rod pushes upward on the right side and the valve spring pushes upward on the left side. The lower portion of the rocker arm and the area around the mounting stud will see tension but the cracked area should only see compressive forces yet it has two fatigue cracks.

The metallurgical analysis found that area of the rocker was left in tension after heat treating. Then the normal operating stress put it into compression and when the pushrod retracted it went back into tension. It saw tension 6000+ times per minute, then compression, then tension, more than 6000 times per minute, and eventually suffered a pair of fatigue cracks.

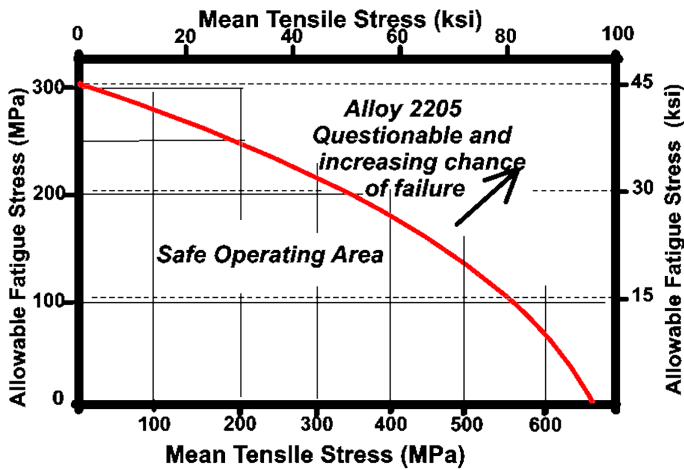
FIGURE 6.5 This is a modified Goodman diagram for the duplex stainless alloy 2205 and shows the safe operating area for the combined fatigue and steady state stresses.

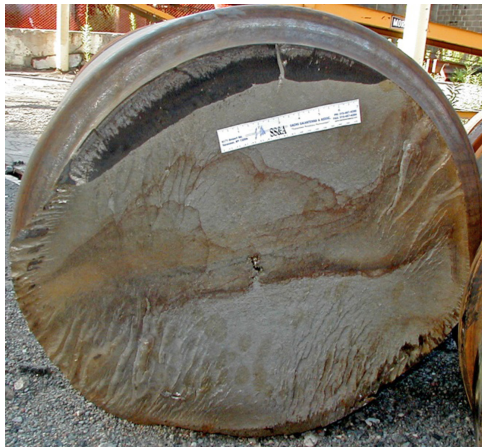
PHOTO 6.14 A forming roll from a steel mill that was very heavily loaded. The blackened area is oxidation on an older crack surface and the final fracture is the lower third of the roll.

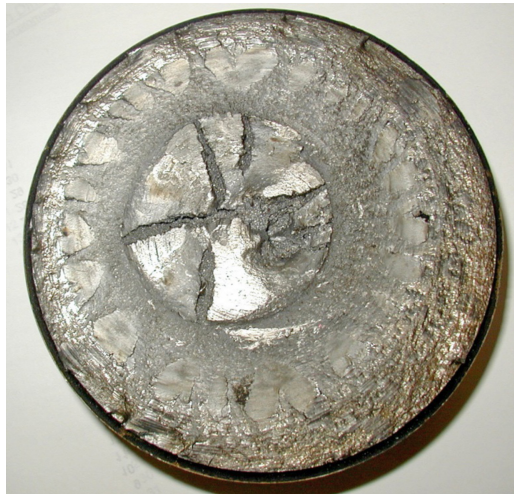
PHOTO 6.15 The very low cycle fatigue failure of the ductile input shaft for a large machine. One substantial clue to the failure cause is the ratchet marks.

The fracture shown in Photo 6.15 looks suspiciously like a torsional ductile overload failure. It is from the input shaft of a large machine and close inspection of the face shows a substantial amount of smearing as the pieces twisted apart. The clue that it is VLC lies in looking closely at the OD of the fracture, the area from 11:00 to 1:00 o'clock and the area from about 6:30 to 7:30 o'clock, where several fatigue origins are evident. In order for these to occur the unit had to have been heavily loaded. Our suspicion is that the failure probably took about 8 to 10 fatigue cycles from the first significant load to final fracture but the question that has to be addressed at the plant site is, "Did this tremendous 'fatigue overload' occur immediately before failure or was it a recurring event?" Did the failure occur from a series of eight or ten immediately sequential loads or were the loads applied at widely differing times?

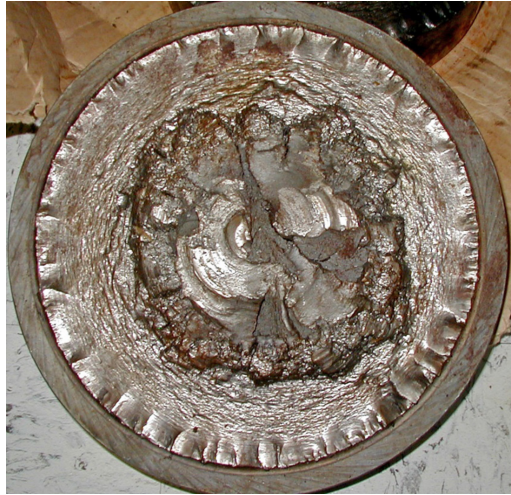
PHOTO 6.16 Inspection of the ratchet marks on the low cycle fatigue failure shows that it failed from repeated torsional stress application. But as the failure progressed, because of the relatively ductile material and the many origins, the failure was comparatively flat.

The shaft shown in Photo 6.16 took longer from initiation to final fracture and really belongs in the category of low cycle (LC) and not VLC but this is a good place to introduce it. Examining this paper machine drive shaft, we see the perimeter is

ringed with ratchet marks showing numerous failure origins. Two thoughts to keep in mind during the diagnosis are:

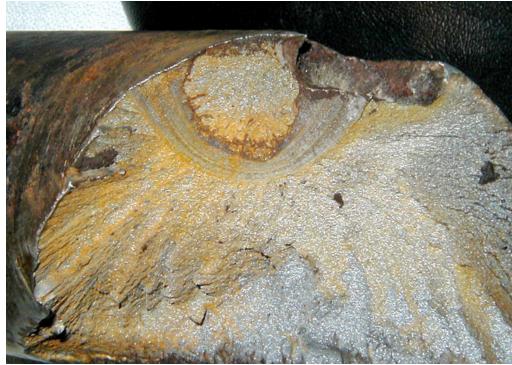
PHOTO 6.17 This unusual LC fatigue failure shows an area of brittle fracture followed by a series of fatigue propagation marks, and finally a huge instantaneous zone.

One of the most interesting and unusual occurs when there are alternating bands of ductile rupture and cleavage on the fracture face. Photo 6.17 shows the fracture of a 100 mm (4”) low speed drive shaft for a curing oven that was having a problem with the oven chain snagging, i.e., periodically seizing in position, and then

breaking loose. Looking at the fracture, in the upper left corner of the keyway there are a series of fatigue striations over about 6 mm (1/4") followed by a 20 mm (0.8") wide brittle fracture area. This was followed by a 10 mm (0.4") wide area of progression marks and then the entire shaft snapped off. Interpreting these we see:

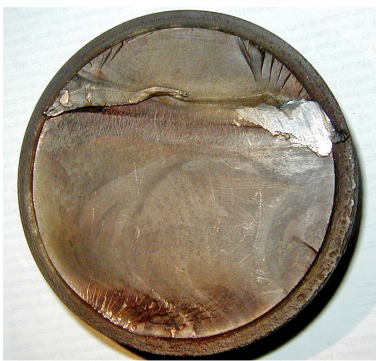
PHOTO EX6.19 The fatigue failure of this paper mill refiner shaft was substantially hastened by the corrosion around the step in the shaft. The diagram to the right shows them major points referred to in the text.

- Improve the shaft alignment to eliminate the rotating bending load.
- Tape or coat the shaft to try to reduce the fatigue strength deterioration from corrosion.
- Add a concentricity specification to the shaft drawing to reduce the plain bending load.

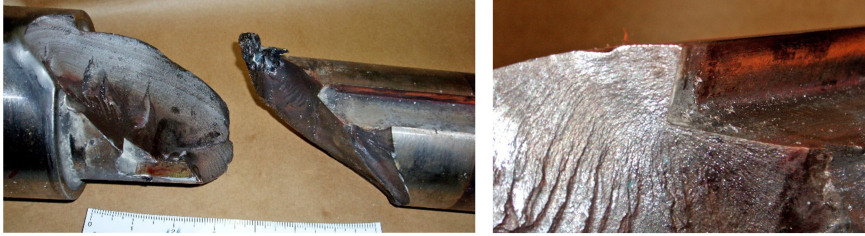
Example 5 – Photos EX6.23 and EX6.24

PHOTO EX6.23 AND EX6.24 These are two photos of a drive shaft with the angle of the fracture showing that the cause was a torsional fatigue stress.

Both Photos EX6.23 and EX6.24 (and Photo 6.1 earlier in this chapter) show views of an 86 mm ($\approx 3.5"$) drive shaft from a process winder. The plant had had problems with short coupling life and had recently replaced the coupling with a larger one. The coupling fit is at the far right side, with the winder toward the left.

Inspection – The diagonal fracture face shows this is a torsional failure. Then, examining the surface we see that:

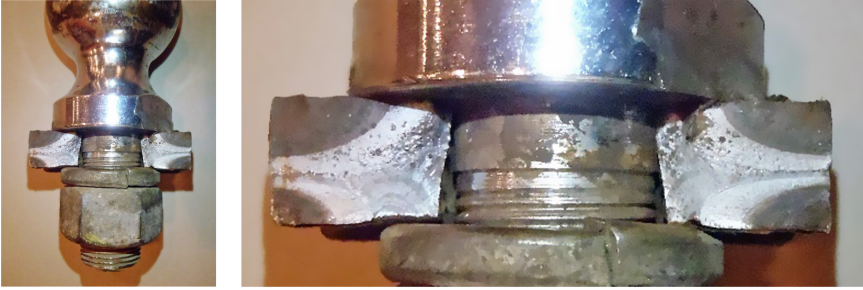
Example 6 – Photos EX6.25 and EX6.26

PHOTOS EX6.25 AND EX6.26 Two great views of a torsional failure of a flat section.

We were doing a class for a company that had work crews around much of the world when one of the attendees brought this into the room for the hands-on portion of the class. The trailer hitch was stamped with a maximum load rating of 6000 lbs and a maximum tongue weight of 600 lbs, yet their product seldom weighed that little.

It is an interesting example of a torsional fatigue failure of a flat bar. We can see origins at each of the four corners, with four relatively small fatigue zones and two large instantaneous zones. It also appears that the fit of the stem of the hitch ball is not snug in the hitch, but that may be the result of deformation that occurred during the failure.

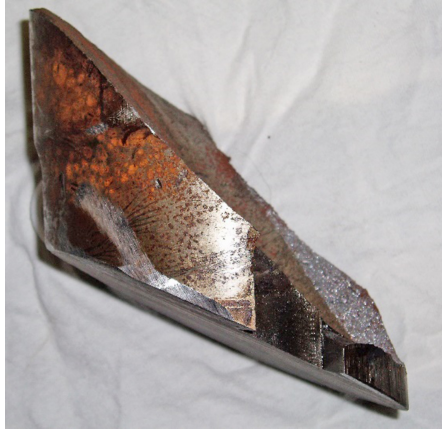
PHOTO EX6.27 shows a slice from a shaft that was sent to us. As you can see, the piece was cut off on an angle and the fracture face is at 45° to the centerline of the shaft.

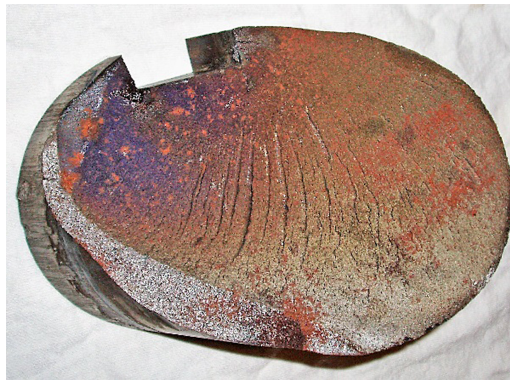
PHOTO EX6.28 is a view of the actual fracture face and the change in surface roughness shows it's the result of torsional fatigue.

Photo EX6.28 is a better view of the fracture face and from it we can see:

- The angle of the fracture tells that it is the result of a pure torsional stress.
- There is corrosion on the face but that is the result of a long and unprotected wait before the piece was sent to us.
- There is fretting corrosion in the keyway.
- The fatigue zone is relatively large but has numerous river marks across it.
- The final fracture zone is relatively small.
- We don't show it, but the elastomer elements of the flexible coupling were also destroyed.

Conclusions and recommendations – From the 45° angle of the fracture face, it's relatively obvious that this is a fatigue failure. Even though the IZ is small, the fracture face with the river marks shows that the failure was relatively rapid.

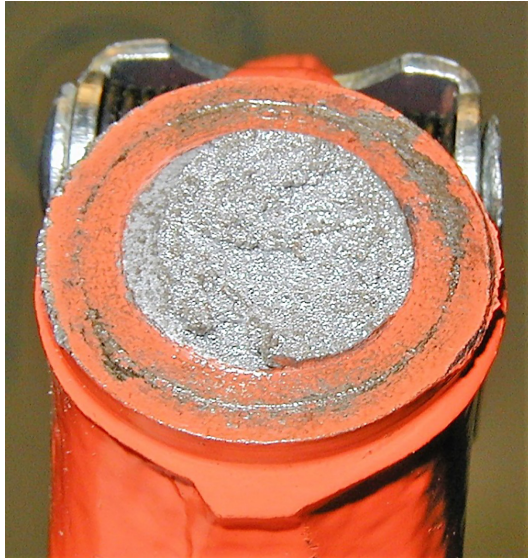
Example 7 – Photo EX6.29

PHOTO EX6.29 Look carefully at the left side of this fracture face, and you can see it has been side loaded more than once!

The photo shows a broken crane hook. At the top of the photo is the latch and from that we know that the tip of the hook lies in line with the latch.

At first glance it looks like a brittle fracture and people might feel this was from a single overload. But looking closely at the left-hand side of the fracture shows that there are several progression marks.

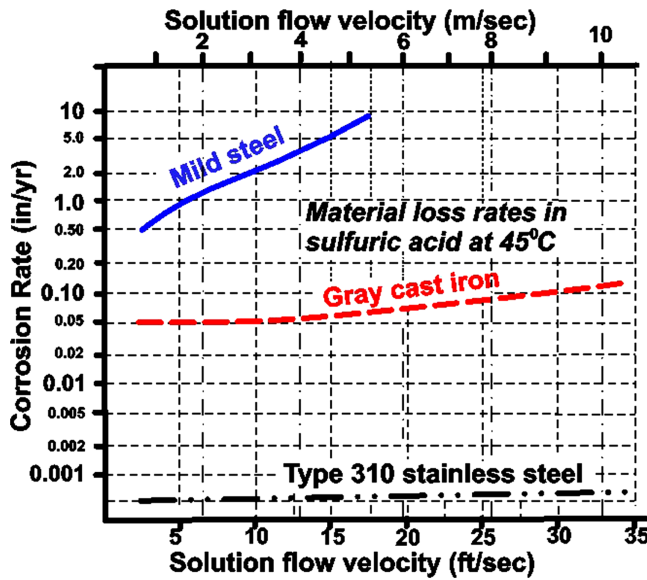
FIGURE 7.12 Showing how the attack rate on three alloys is affected by both solution velocity and metallurgical structure.

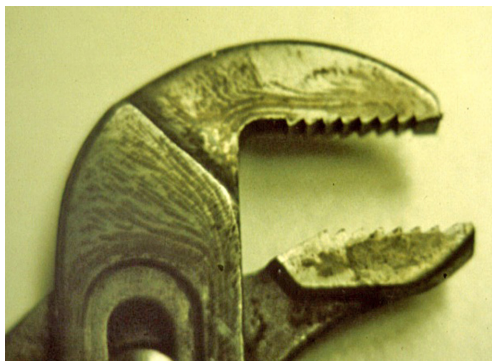
PHOTO 7.1 Uniform corrosion of a forging showing the anode and cathode areas resulting from the internal residual stress.

This is the rusting (or oxidation) frequently seen on an exposed area of steel. The attack may appear relatively uniform, but more often there will be irregularities caused by local conditions and the surface won't be smooth. Photo 7.1 shows a pair of slip-joint pliers with corroded bands on the face. Referring back to Figure 7.2,

one can see that it is the anode areas that are rusted while the cathode areas are still clean and like new. Yet we know that, six months from now, the entire pliers set will be rusty. This is a great example of uniform corrosion where today's anode is tomorrow's cathode with the two poles constantly shifting back and forth as the entire piece slowly rusts away.

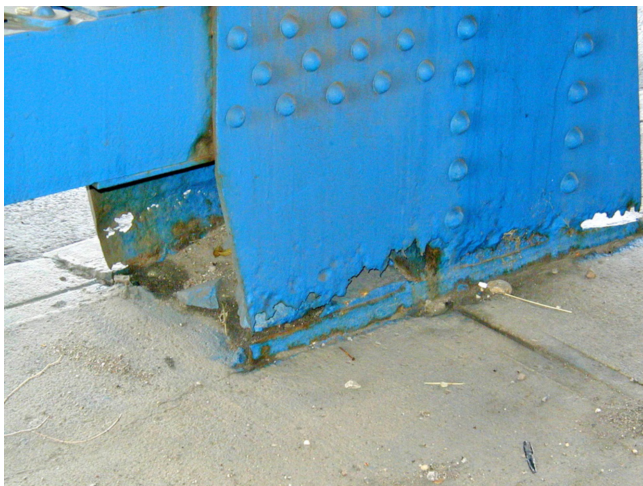
PHOTO 7.2 Long term lack of cleaning and coating and the layer of roadside debris lead to the corrosion of this railroad bridge support.

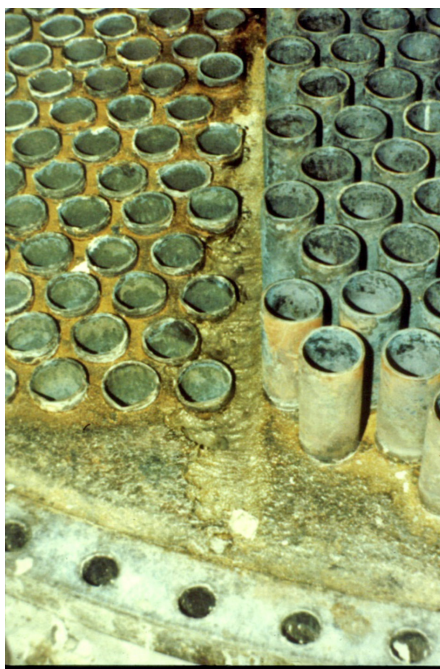
PHOTO 7.3 The corroded line up the center of this tube sheet photo is a groove resulting from the increased fluid velocity from leakage under a tube sheet baffle.

But uniform corrosion is also dependent on flow velocity. Photo 7.3 shows a large heat exchanger with severe erosion in the area between the two tube passes. The plant personnel routinely ignored replacing the baffle gasket, allowing fluid to leak under the baffle plate at high velocity. The flow velocity scrubbed the corrosion product off the tube sheet, keeping the corrosion rate at a relatively high level and corroding that area at a much higher rate than the rest of the tube sheet. After several years, leaks in the tube sheets required replacement at a tremendous cost.

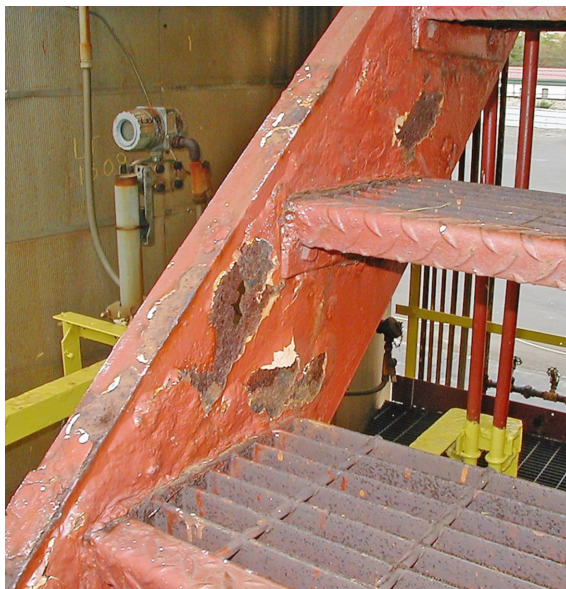
PHOTO 7.4 Despite the nonuniform appearance, this is uniform corrosion of a stairway in a chemical plant and the holes are where the repeated blows from workers shoes damage the poorly applied coating.

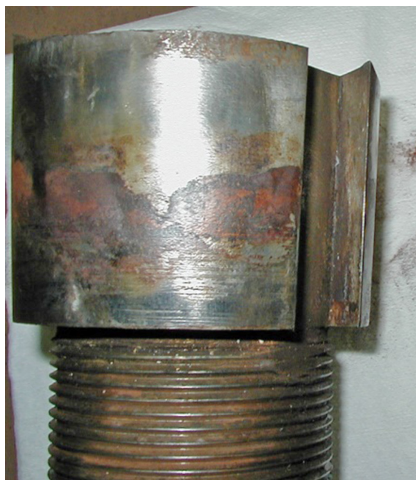
PHOTO 7.5 The discolored portion of this shaft fit is fretting. The brownish-black debris is oxidized steel and results from movement between the two components.

Dark brown or black discoloration between two ferrous parts. (Black is usually an indication that water was present.) Photo 7.5 shows the impeller fit on a pump shaft and the brownish-black discoloration is fretting, the result of looseness between the two components.

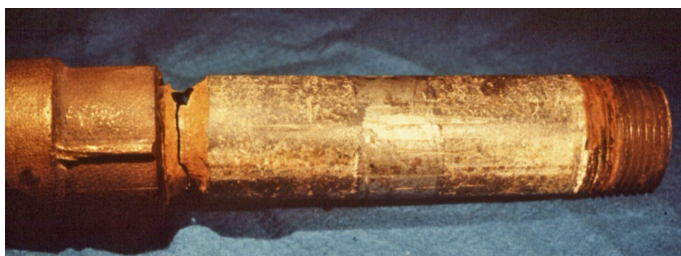
PHOTO 7.6 A well pipe assembly made from bronze, steel, and what was originally a galvanized pipe. But the zinc had long ago corroded to zinc hydroxide and couldn't protect the freshly cut steel threads.

Photo 7.6 shows an example of galvanic corrosion. The pieces were taken out of a water well nine months after the well had been repiped. On the left is a bronze foot

valve that is in like-new condition. To the right of it is a pipe nipple that was originally galvanized. (In the middle of the galvanized pipe is a shiny section that is a piece of cellophane tape wrapped around the pipe.) The nipple had been in the well for many years while the galvanizing was doing its duty protecting the steel. However, when the well was repiped the fitter shortened the nipple and recut the threads on it, exposing clean steel. Unfortunately, after years of use, the galvanizing was no longer there with most of the zinc having corroded to zinc hydroxide, leaving the pipe

unprotected. As a result, the assembly surfaces exposed to the water consisted of bronze, freshly cut steel, and old steel. The resulting galvanic corrosion is obvious.

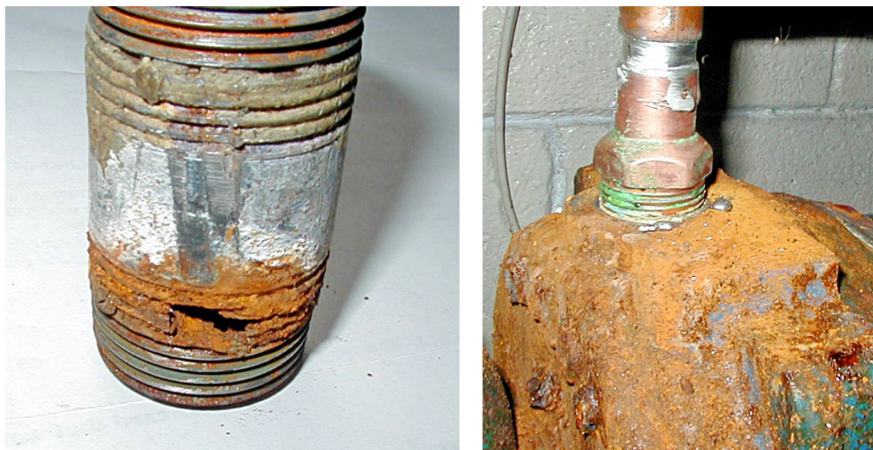
PHOTOS 7.7 AND 7.8 The first photo is of a small galvanized steel nipple. It was screwed into the cast iron pump housing shown in the second photo. The top of the housing was always damp and the protection of the galvanizing was eventually exhausted. The repair consisted of replacing the steel nipple with a copper one. Now the cast iron housing will be the sacrificial one, but the damage will be distributed over a much larger area and it will be many years before a replacement is needed.

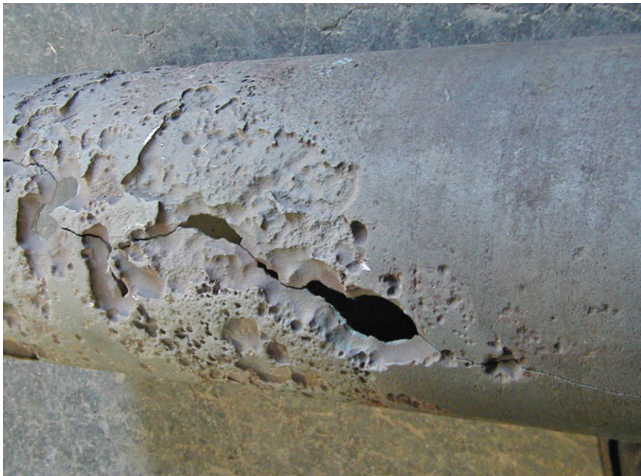
PHOTO 7.9 A fire water pipe that lasted about 30 years. When it was removed from service the leak was visible but it wasn't until the piece was sandblasted to remove the graphite that the extent of the attack became apparent.

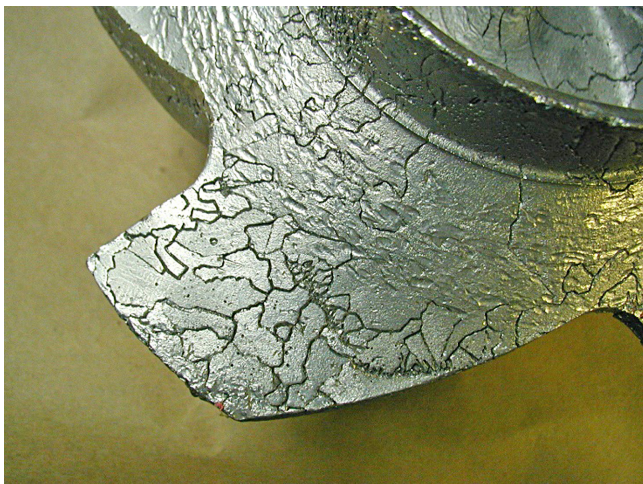
PHOTO 7.10 This is a stainless steel pump impeller that was improperly heat treated. When exposed to concentrated phosphoric acid the grain boundaries were attacked and the grain structure can be clearly seen in the photo.
