PRACTICAL PLANT FAILURE ANALYSIS

A Guide to Understanding Machinery Deterioration
and Improving Equipment Reliability

Neville W. Sachs, P.E.

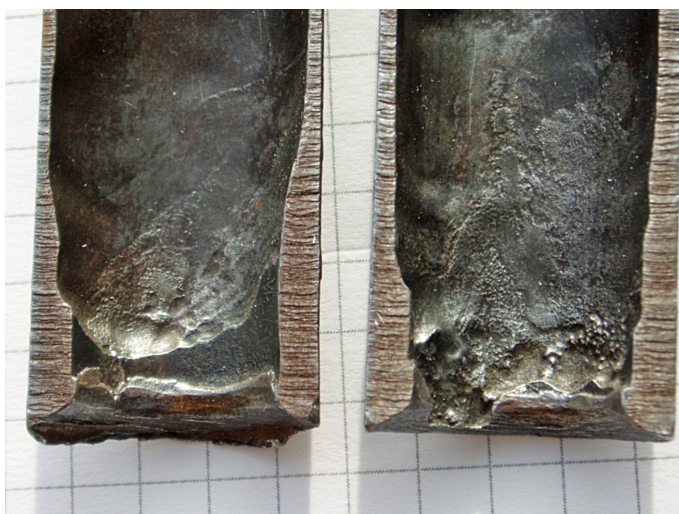
PHOTO 7.11 Two corroded tubes where the liquid ammonia comes in the bottom of the tubes and flashes into a gas. There is some deformation on the lower edges of the tubes from the removal tools but just above that can be seen an area where the wall has been substantially thinned. The tube to the left shows more classical symptoms of erosion while the tube to the right shows obvious erosion and corrosion attack.

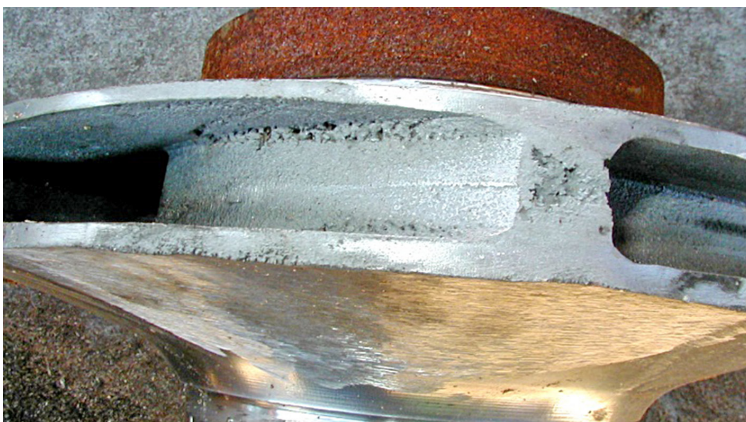
PHOTO 7.13 Recirculation cavitation damage on a pump impeller.

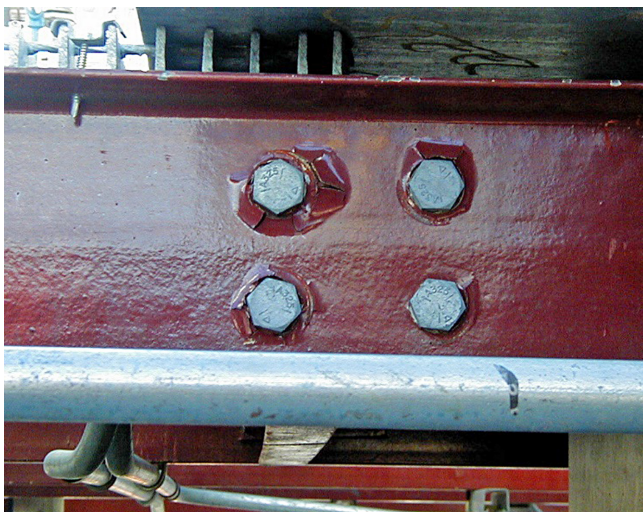
PHOTO 7.14 The corrosion raising the paint around these four bolts is concentration cell corrosion and is the result of the chemistry plus problems with doing a good job of coating.

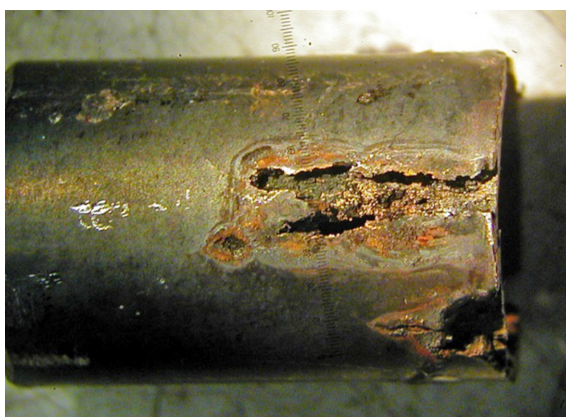
PHOTO 7.15 Crevice corrosion of a stainless steel tube that was tight up against another tube.

Location is the key – under rivet heads, bolt heads, nuts, lap joints, incomplete weld joints, area between gasket and flange faces, absorbent gaskets, etc. The attack shown in Photo 7.15 started at the surface of this Type 304 stainless steel instrument tube that was immediately adjacent to another piece. When the adjacent piece was removed the attack was obvious.

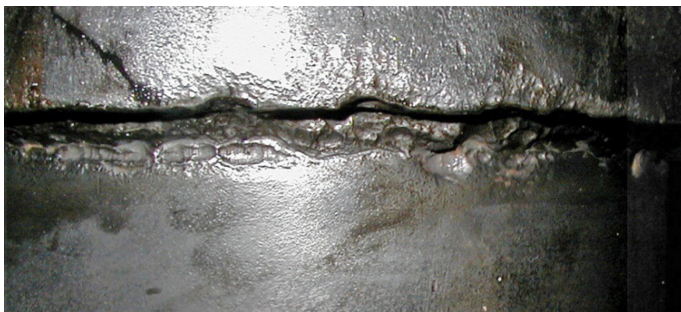
PHOTO 7.16 Pitting corrosion of a steel tube that started alongside the weld because the residual stress from the welding made the adjacent parent metal anodic.

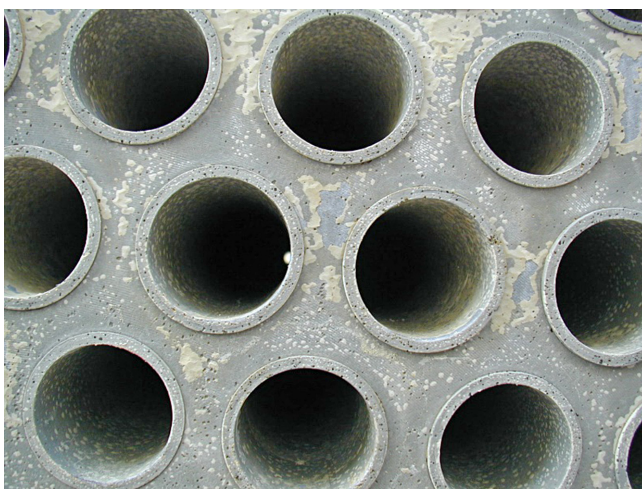
PHOTO 7.19 Pitting of the end of a heat exchanger that happened when the plant wanted to accelerate the cleaning of the heat exchanger bundle. They intentionally increased the chloride concentration in the cleaning solution and perforated several tubes.

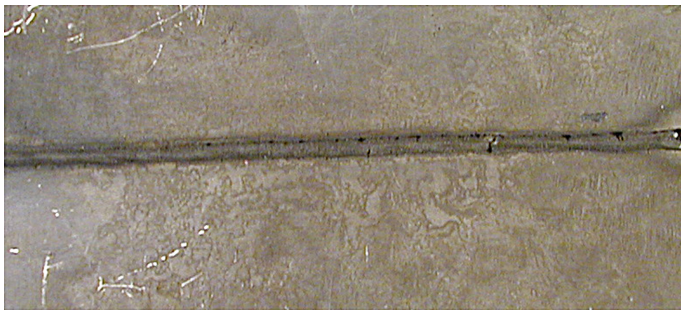
PHOTO 7.20 Pitting alongside the weld in a Type 316 stainless steel duct. A good practice is to always ensure that the weld metal is more corrosion resistant than the parent metal.

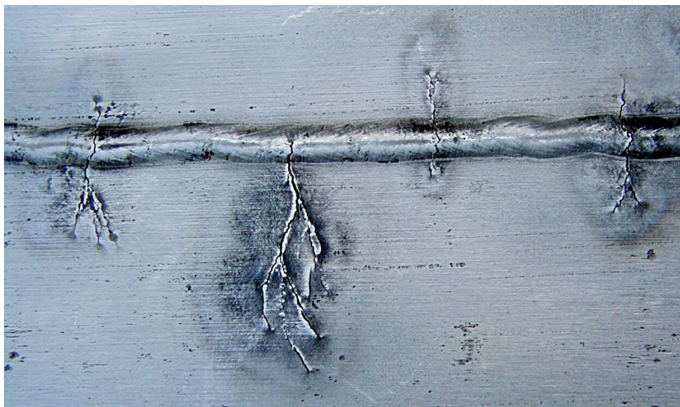
PHOTO 7.21 Stress corrosion cracking in a 40+-year-old tank that appeared shortly after they raised the temperature of the cleaning solution.

An excellent example of the need for all three can be seen in a milk tank inspection project we worked on. For many years, we routinely inspected the welds in a series of Type 304 stainless steel tanks (shown in Photo 7.21) to ensure there were

no cracks, and for many years we found nothing of concern. Then one year we found a small crack in one of the welds. The plant people said nothing had changed, but the next year we found several cracks and had lengthy meetings to determine why they had appeared. Eventually it came out that they had increased the temperature of the rinse water used to clean the tanks. The atmosphere where the cracking started hadn't changed and the metal certainly hadn't changed, but the increased temperature increased the stress in the welds – and SCC appeared.

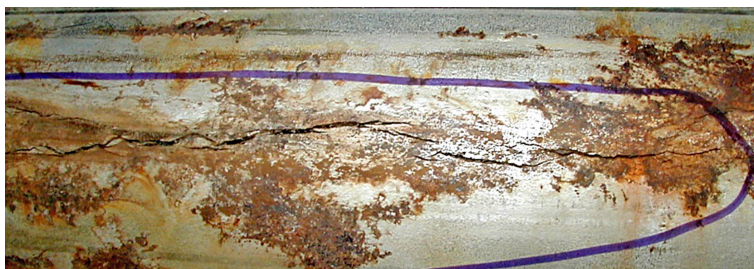
PHOTO 7.22 These branched irregular cracks are typical of stress corrosion cracking.

These are ragged irregular fine cracks with multiple branches while the rest of the piece looks absolutely unaffected. The cracks frequently start at pits. Photo 7.22 shows a 1.2 cm (1/2") tube with a lengthy jagged and disjointed stress corrosion crack.

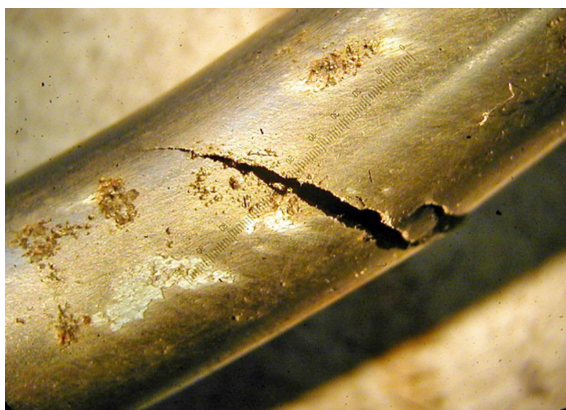
PHOTO 7.23 These stress corrosion cracks started at the pits. As their diagonal layout on the tube suggests, there is a torsional stress in it.

1. The amount of stress can be small, as low as 14 MPa (2000 psi), but it can also range up to almost the yield strength of the material.
2. Discontinuities such as pits, gouges, and deep scratches are frequently starting points. Photo 7.23 shows a view of a small diameter instrument tube as seen through a microscope. The stress corrosion crack is obvious, and a close examination can see the pits where it started.

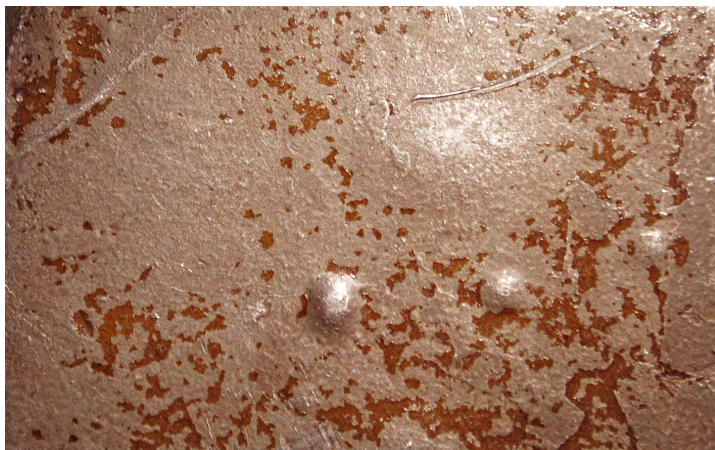
PHOTO 7.24 A steel plate with some hydrogen blisters that are about 9 mm (3/8") in diameter.

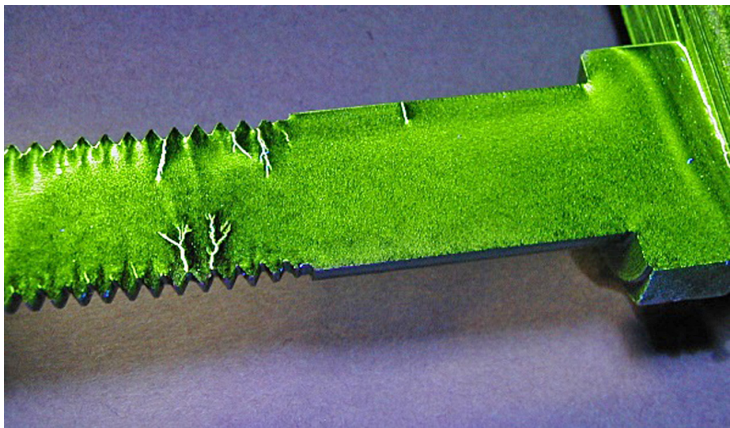
PHOTO 7.25 The fact that these cracks are so disjointed indicates that the cause has to be internal.

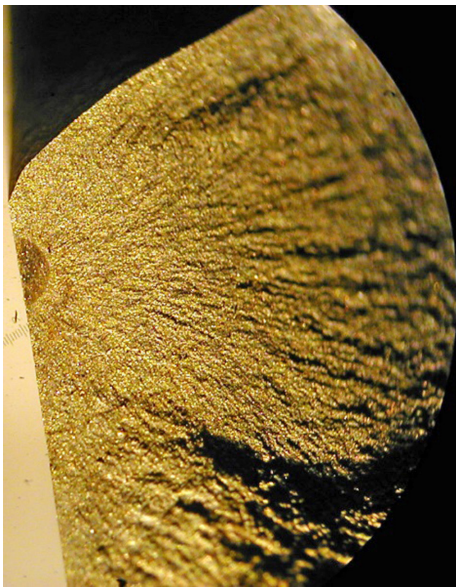
PHOTO 7.26 A cracked spring that started with corrosion and hydrogen damage.

This is a photo made through a 7X microscope and the semi-circular original crack is plainly visible.

This mechanism can also appear as seen in Photo 7.26. This is a spring with a corroded mounting surface. The end coil was ground flat and it rested on a plate that was frequently wet. Eventually some corrosion occurred, and the generated hydrogen combined with the high hardness of the spring resulted in several failures.

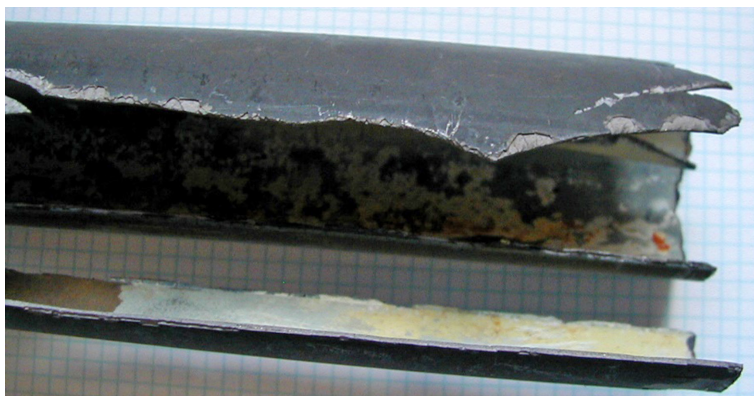
PHOTO 7.27 True hydrogen embrittlement where the ductile titanium has absorbed hydrogen and become the very brittle titanium hydride.

be seen that there are chips out of the tube that appear to be classical brittle fractures. Yet the portion of the tube that was not in the gas stream is still as ductile as a paper clip! The tube was exposed to steam and the free hydrogen atoms have converted the external portion of it to titanium hydride and it is almost as brittle as glass.

1. The metal absorbs hydrogen and is converted to a brittle non-metallic compound. For example, Photo 7.27 shows a piece of titanium tubing that is about 2 cm (1 in) in diameter. Looking at the right side of the photo it can

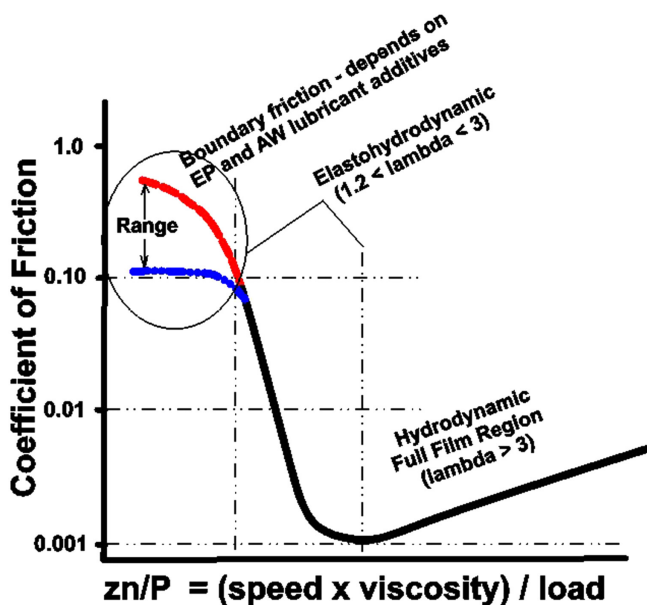
FIGURE 8.6 The Stribeck Curve describing the effect of film thickness on friction coefficient is based on the work of several scientists in the United States and Germany. (Adapted from Stribeck, R. *Die wesentlichen Eigenschaften der Gleit- und Rollenlager*. Zeit. des VDI 46, 1902.)

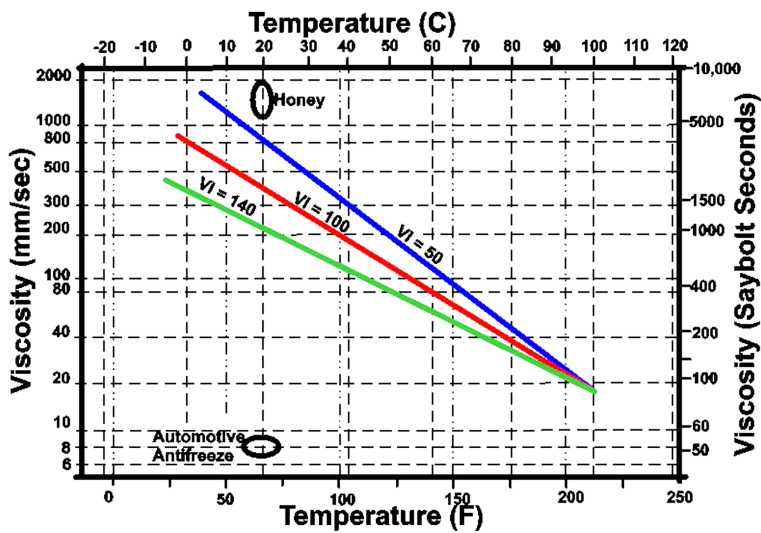
FIGURE 8.7 This shows how three oils with differing VIs change viscosity with temperature and compares them with both honey and antifreeze at room temperature.

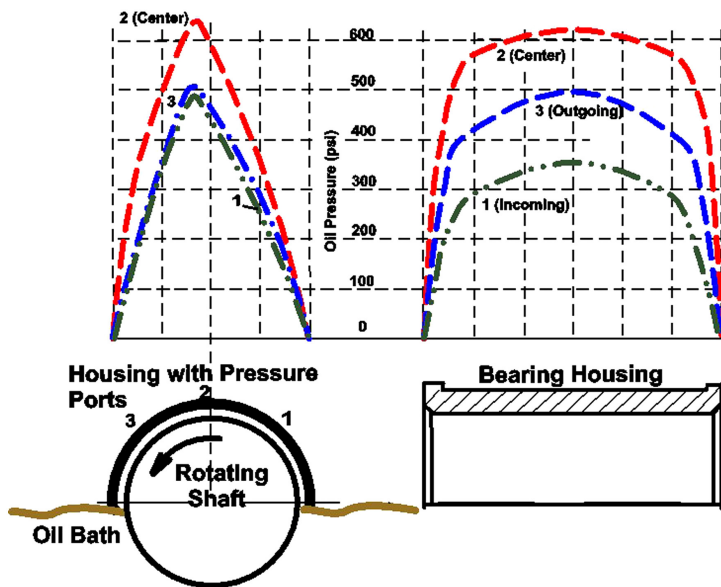
FIGURE 8.16 A sketch of Beauchamp Tower's original experiment where he determined how plain bearing lubrication actually works. The bearing was 4" diameter \times 6" long (100 mm OD and 150 mm long) and ran in a light oil bath.

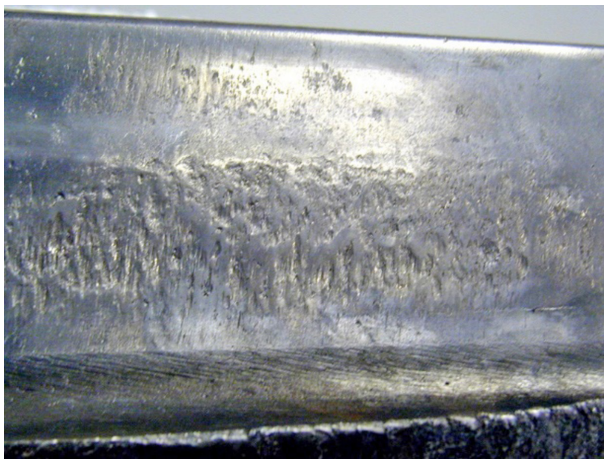
PHOTO 8.1 A close up of a gear tooth with severe adhesive wear. The mating tooth has rubbed against this one and torn pieces out of it through solid-phase welding.

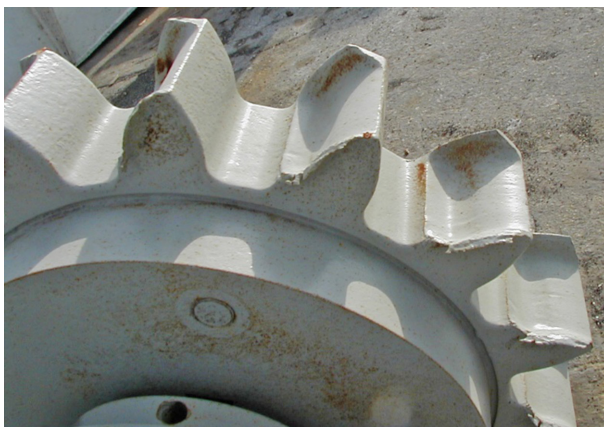
PHOTO 8.4 This wood yard sprocket has been heavily worn by the abrasive sand carried by the logs.

Detection of abrasive wear in metals often requires the use of metallography to look at the outermost layer of the grain structure to see if it is deformed from the severe contact stress. Other times, such as in Photo 8.4 it is relatively obvious that the piece has been abraded away. This photo shows a tremendously worn cast iron chain sprocket from a wood yard and the source of the wear was a sandy area.

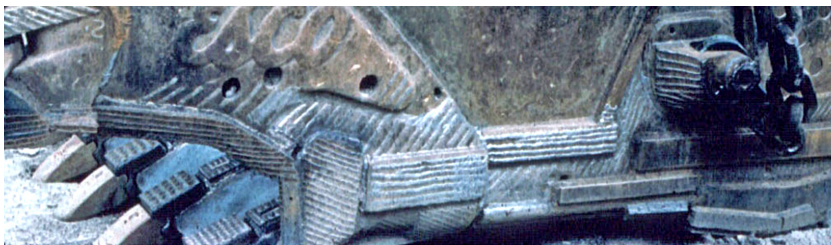
PHOTO 8.5 A great example of using hardfaced weld alloys to improve the wear resistance of this drag line bucket. Note that different alloys may be used depending on the material being mined. (A different overlay would be used for sand than would be used in hard rock.)

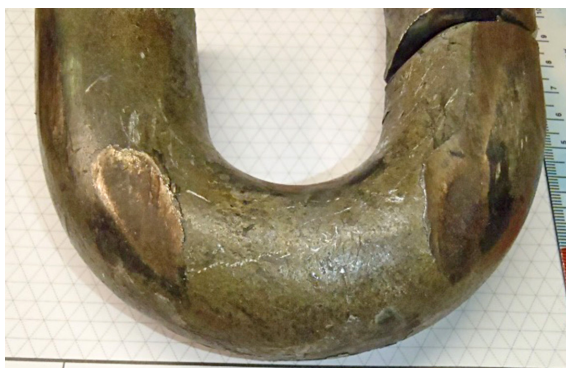
PHOTO 8.6 A ~38 mm (1.5") thick chain link from a mining operation with two badly abraded spots where the chain didn't have enough clearance. The pushed up material is proof of the gouging abrasion, and if the chain had been harder it wouldn't have worn so much. (But that might cause other problems.)

In nonmetallic materials abrasive wear usually shows grooves or gouges, frequently with small scrapings (or shards) of parent material alongside the damage path (see Photo 8.6).

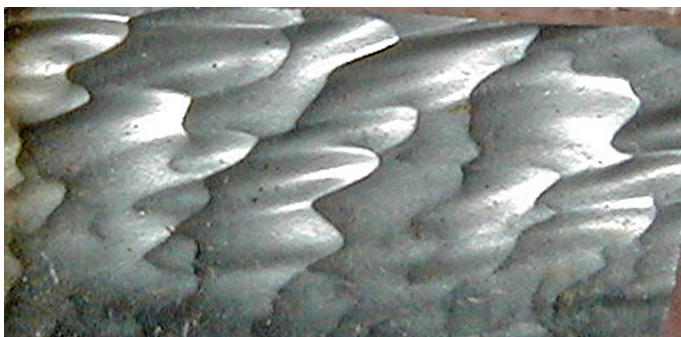
PHOTO 8.8 A closeup of the eroded worn surface of a pump impeller. (The flow was from left to right.)

Photo 8.7 shows a diaphragm out of a large centrifugal compressor with substantial erosion damage from a wet flowstream at 5000 rpm on a 450 mm radius. Photo 8.8 shows the surface of a pump impeller that suffered erosion from solid particles in the flowstream.

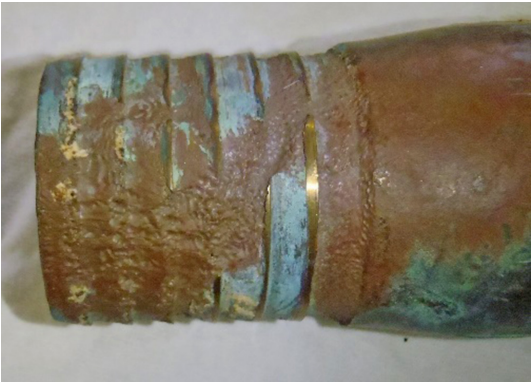
PHOTO 8.9 A copper fitting with some corrosion, but mainly erosion damage. It should be noted that, if there had been no corrosion, the leak would never have happened.

Photo 8.9 is interesting because it looks as though it could be solely a corrosion problem, but actually a major contributor was erosion. This is a copper hose fitting that was used to carry some slightly acidic water from a pumping operation in a national forest. The leak started out as an occasional drip and within a couple of weeks was a steady spray. The path across the fitting is easy to see, while the oxide in the unattacked areas speaks to the corrosion resistance of the copper.

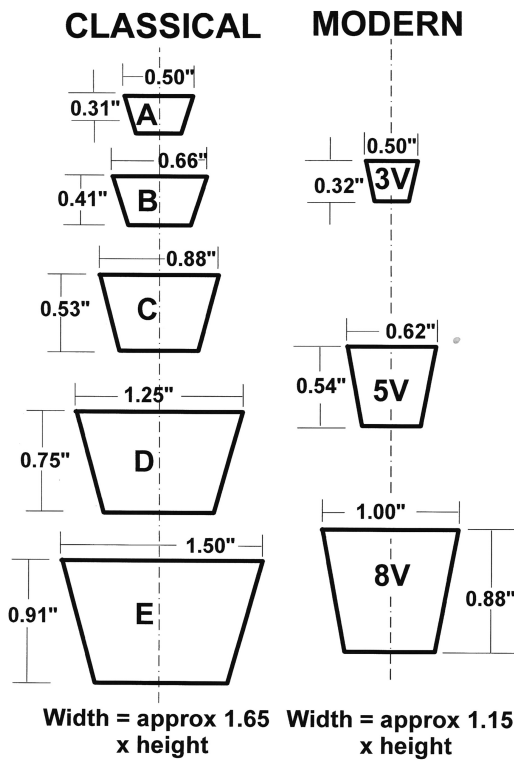
FIGURE 9.2 Showing the difference between the original and “modern” V-belts used in North America.

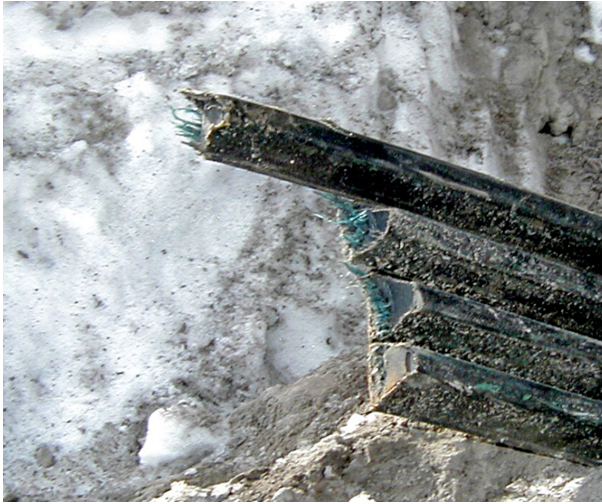
PHOTO 9.2 This shows the instantaneous failure of a group of four belts. There is no fraying of the tension members and that tells that the failure happened very rapidly. This is similar to a ductile or brittle overload of a metallic piece and says that the cause of the failure was present *immediately* before the failure occurred.

4. Examine the broken V-belt.
 - a. What do the ends of the tension members look like? Are they unfrayed or only slightly frayed, indicative of a very short-term overload failure as shown in Photo 9.2, or are they severely frayed, showing a long-term failure as seen in Photo 9.3?

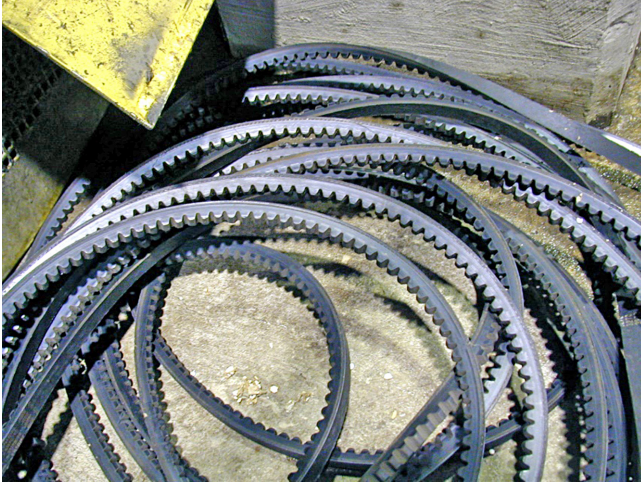
PHOTO 9.6 This is a pile of belts that has just been removed from a fan. The elastomer on the sheave contact surfaces is shiny and polished, proof that they have been slipping excessively.

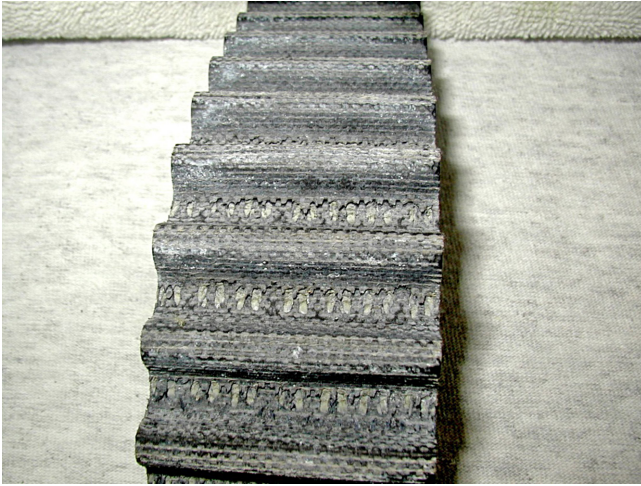
PHOTO 9.8 The worn teeth on this synchronous belt are breaking off and it has worn through to the tension members, proof that the belt has reached the end of its design life. It shows some indication of harder contact on the right side and that leads to slightly suspect alignment.

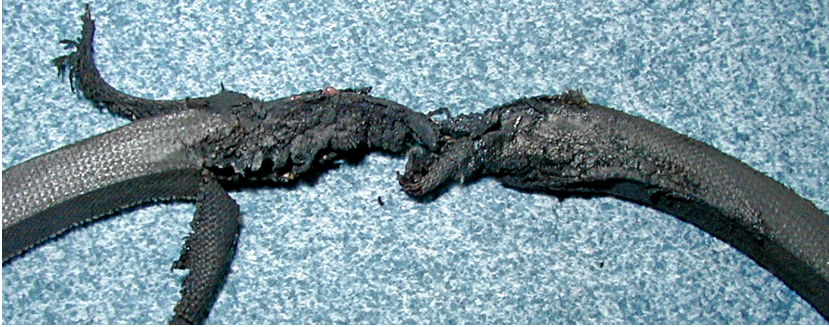
PHOTO 9.9 This is spin burn damage on a small belt. In this case the machine jammed and the belt tension was so loose the drive sheave slipped and heated the belt until it charred. This damage is common when a machine jams but it can also happen from lack of tensioning. During operation a belt constantly stretches and, on a machine such as a fan, when the tension ratio goes over about 16 (5% slip) the chance of a catastrophic failure increases rapidly.

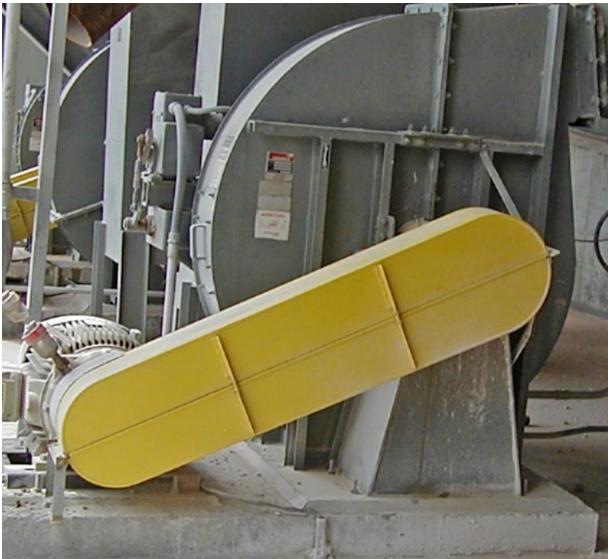
PHOTO 9.10 A sealed belt guard with the resultant trapped heat helping shorten the belt life. In addition, this construction effectively eliminates the ability to inspect the belts in operation. (But a strobe light on the shafts could be used to calculate the slip ratio.)

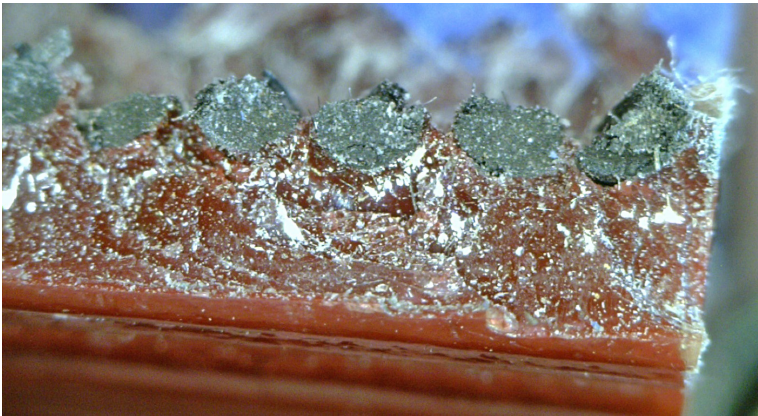
PHOTO 9.11 This photo was taken though a microscope and shows a section of a synchronous belt. Along the top can be seen the round tension member cords and the fact that they are broken off cleanly indicates that the belt failure was either the result of a shock loaded or being pinched.

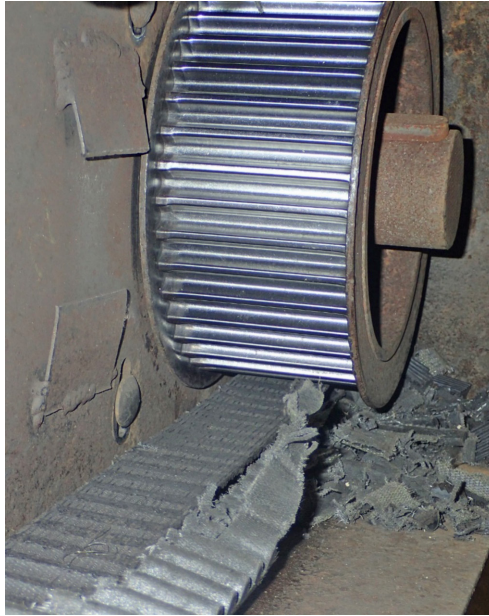
PHOTO 9.12 A heavily worn synchronous belt sprocket that should be replaced, but note the broken belt. The ripped backing caught our eyes and further inspection found the tooth fractures started at the center of the belt. The most likely cause of the belt failure was the combination of gross misalignment and rolling the belt onto the sprocket, damaging the backing and tension members.

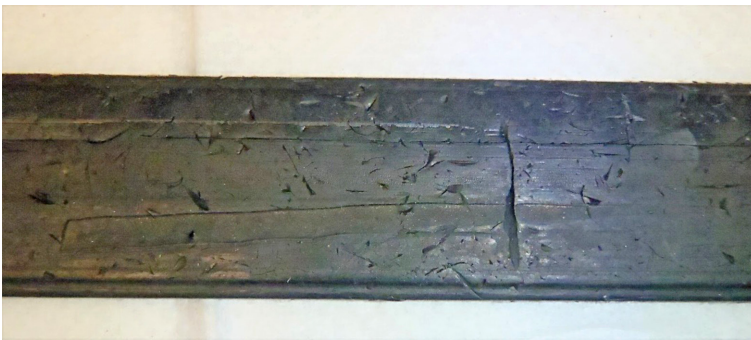
PHOTO 9.13 Look at the surface of the top cover on this synchronous belt!! The foreign object imprints have caused stress concentrations that will significantly reduce the life of the tension members.

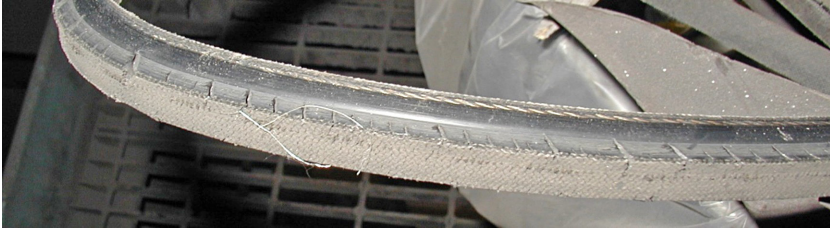
PHOTO 9.14 This is a belt that has been removed from service. The cracks in the elastomer show that it has become hard and brittle and the belt should be replaced. But, look closely at the pattern on the side of the belts. The different surface appearances show that it has been used in the wrong sheave group, i.e., this is a modern V-belt that has been used in classical V-belt sheave.

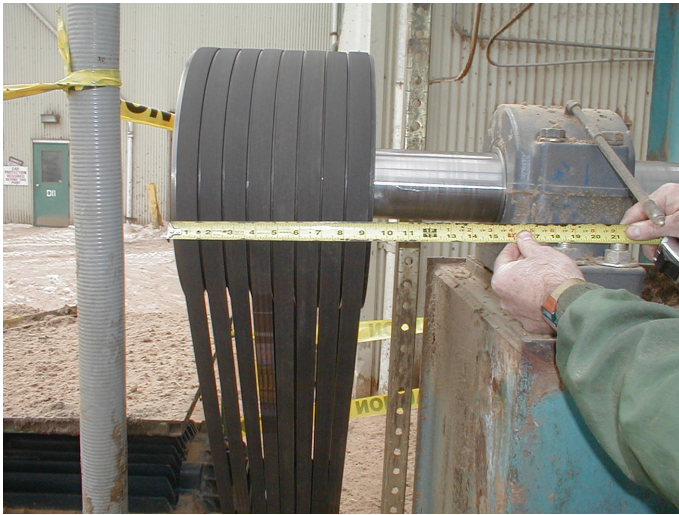
PHOTO 9.15 This doesn't show a failed belt but is a great lesson on what a belt drive shouldn't look like. The additional load on the bearing and shaft from the sheave being installed this far away from the bearing is ridiculous. If the design were better, the sheave could have been moved in by at least 4 in (100 mm) and the bearing life would be at least tripled.

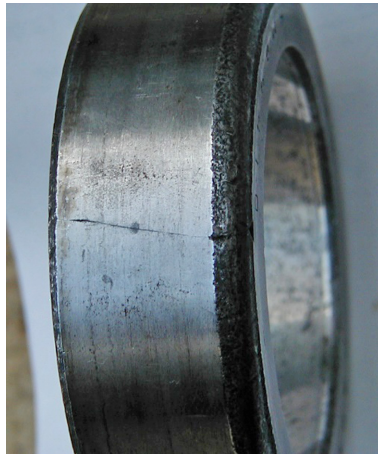
PHOTO 10.2 This is a case (surface) hardened bearing that has been running cracked for almost a year without catastrophic failure.

Photos 10.2 and 10.3 compare the damage in a case hardened tapered roller bearing with that of a through hardened spherical roller bearing. Both have cracked rings but the two-year-old tapered roller bearing is still in somewhat usable condition, because the crack has not propagated through the core. Meanwhile, the two-week-old spherical bearing has cracked all the way through and is only a short time from a catastrophic failure. Common situations where case hardened bearings are used include paper machine dryer bearings that are subjected to thermal shocks and logging and mining equipment that experiences impact loading.

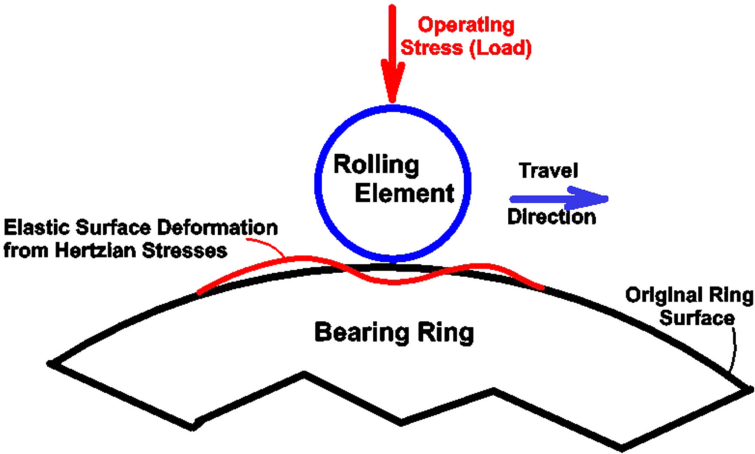
FIGURE 10.3 This sketch shows the elastic deformation that allows Hertzian fatigue to occur.

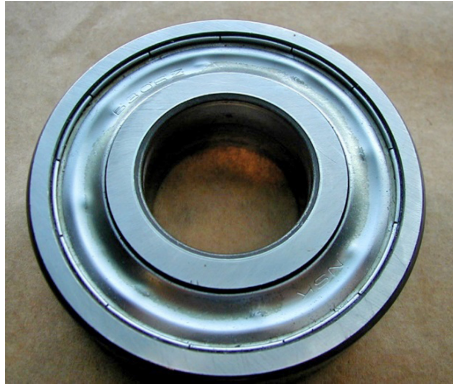
PHOTO 10.5 A shielded bearing where the shield has been collapsed onto the cage and balls by careless greasing.

Photo 10.5 shows a shielded motor bearing that has been destroyed by a zealous but untrained oiler. Shielded bearings can be relubricated if a measured quantity of grease is slowly and carefully pumped in by hand but destroyed bearings with dimpled shields like these can only be produced by an uneducated finger on the trigger of an automatic grease gun.

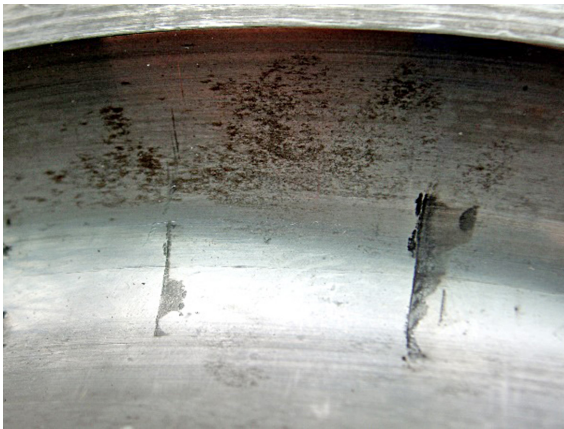
PHOTO 10.6 Two water spots (corrosion locations) on the inner ring of a ball bearing.

Comment – We know the critical effect water has on bearing life. The water contamination typically causes black stains on the rings or in the ball path as shown in Photo 10.6. The photo shows the actual ball path damage and the presence of stains such as these or the ones shown in Photo 10.7 are proof that water has been present.

1. Water gets into the bearing and there is some corrosion.
2. The corrosion generates atomic hydrogen and some of the hydrogen atoms are absorbed into the steel.
3. The hydrogen atoms wander through the steel until they find another hydrogen atom and the two unite to form a hydrogen molecule.
4. The volume of the molecule is much greater than that of the atom and it results in enough internal pressure to cause cracking of the extremely brittle bearing ring.

If we were to clean off the corrosion debris, that black oxide, it wouldn't do any good because the bearing steel already had tiny cracks in it. He went on to say that if we did run the bearing, he felt we would be lucky if it lasted for one-tenth of the L_{10} life.

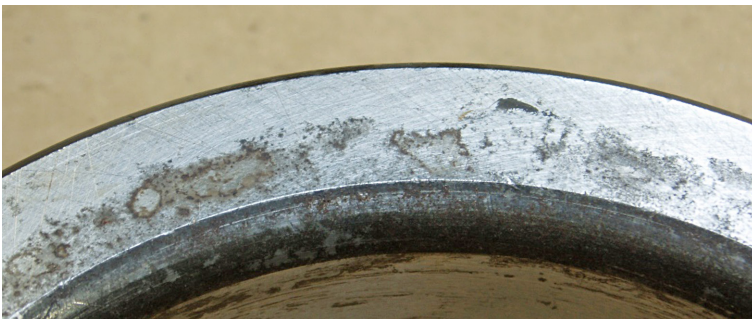
PHOTO 10.7 The side of a bearing and those black spots are also the result of corrosion and proof that water has been present.

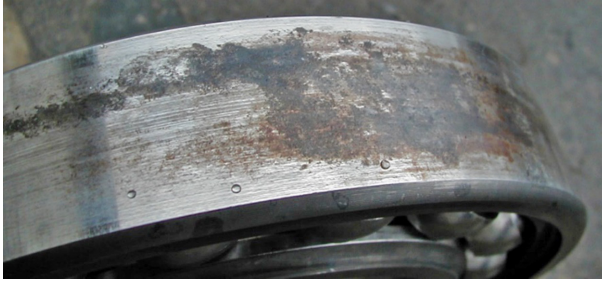
PHOTO 10.9 The dark material on the outer surface of this ring is fretting corrosion and results from looseness between the ring and the mating surface. It is actually a collection of metal particles that have been abraded off the surface and then oxidized into rust.

Photo 10.9 is an example of *fretting*. This bearing was loose in the housing and moved back and forth a tiny bit as the inner ring rotated. The brown-black material is the oxide that the movement created.

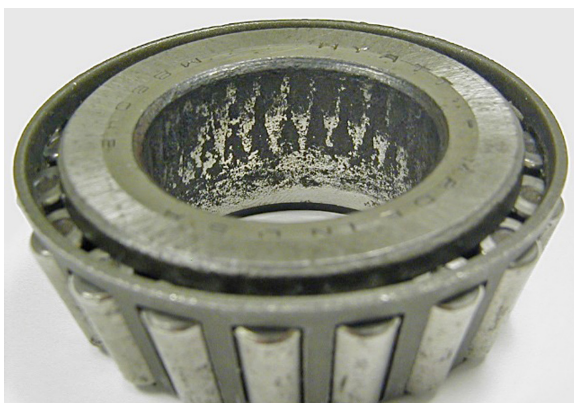
PHOTO 10.13 A tapered roller bearing with an interesting fretting pattern on the inner ring. The pattern resulted from variations in the grinding of the shaft contact surface.

Sometimes this surface fatigue damage will include regular patterns such as that shown in Photo 10.13. People will assign all sorts of causes to this but it is only the repetition of the grinding pattern used in manufacturing superimposed on the loose fit. (This bearing came out of a truck and a dimensional check showed it was likely that the original fits were not what the bearing company specified.) A second interesting point that can be seen in this photo is that the side of the ring is highly polished in a band about 6 mm ($1/4''$) wide, from rotating against the shaft shoulder.

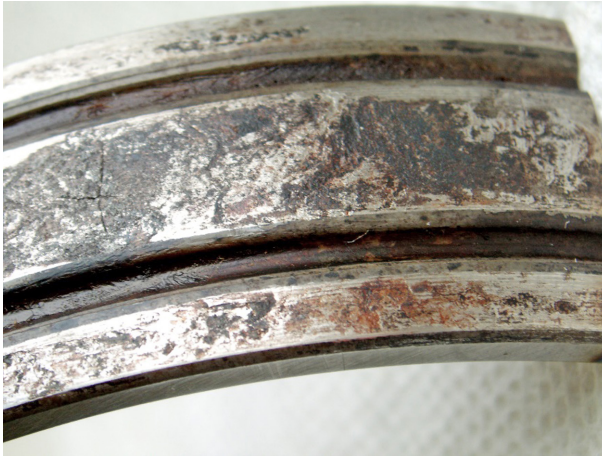
PHOTO 10.14 The star fracture on the left side of the photo and the fretting, both symptoms of looseness, are readily visible on this ball bearing.

One of the reasons a close fit is needed on the outer bearing ring is to distribute the fatigue forces over a larger area. If the ring is loose, the operating forces are concentrated into a smaller area and the possibility of cracking increases. (The poor fit increases the bending stress in the ring.) Photo 10.14 shows the outer ring of a self-aligning pillow block used on a fan and has a star-shaped crack toward the left side of the photo that started on the OD. The inspection found fretting on both the top and the bottom of the ring, showing the pillow block bore was not round and that there was considerable movement between the bearing and the housing. In addition, the black discoloration shows the bearing has been wet. (This puzzled the plant personnel until they realized that the bearing was occasionally subjected to humid outside air while the housing was still around 15°C [~60°F].)

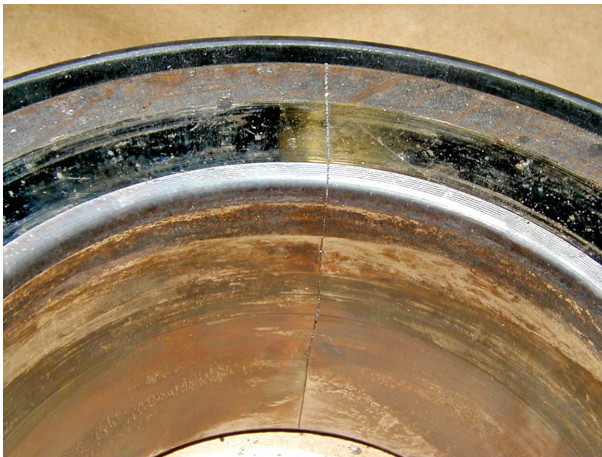
PHOTO 10.15 This shows the cracked inner ring of a spherical roller bearing. The polishing on the side and the smeared inner mounting surface prove the bearing has been loose and spinning on the shaft.

Similar fractures, because of multiple stresses, can happen on the inner ring and Photo 10.15 shows the inner ring of a spherical roller bearing. Looking at it we see:

1. There is a crack across the ring.
2. The shaft mounting surface is heavily fretted and there are polished circumferential bands that show it has been spinning on the shaft.
3. Like the bearing in Photo 10.13, the side of the ring is highly polished, almost mirror-like, from movement and contact against the shaft shoulder.

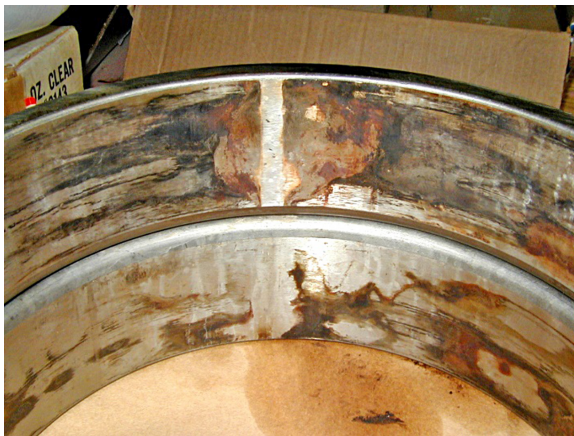
PHOTO 10.16 Both of these inner ring fits look suspicious, but the clear bands show the bearings were not rotating.

One last comment on the subject of shaft and housing fits is that occasionally the initial appearance will be deceiving. In Photo 10.16, the fits are not great and, looking at the fretting on the inner ring surface of the two bearings, the suspicion is that they are very loose. However, the clean unmarked area that was over a lock ring slot shows that, although there was some motion, they were not rotating. (These bearings had horrible outer ring fits and badly contaminated lubricants. The inner ring fit problem was a minimal contribution to their failure.)

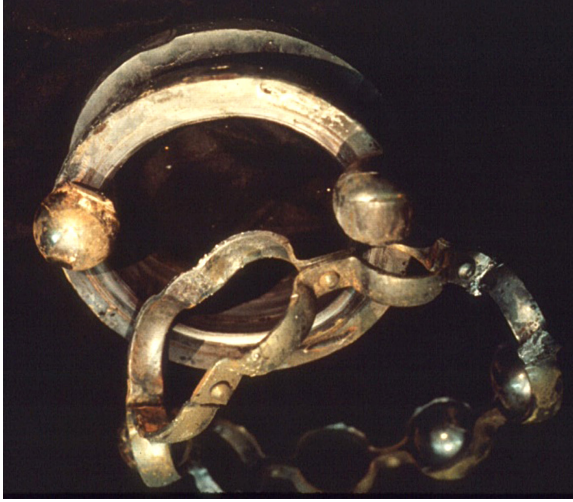
PHOTO 10.18 An absolutely destroyed bearing and it's not worth trying to do a failure analysis because of the severity of the damage can hide the underlying defects.

There will always be an argument between those persons who want to run a piece of equipment until the last possible moment before a tremendous catastrophic failure and those who want to shut the machine down and remove the part at the first indication of a serious defect. The first group is trying to maximize their immediate output while the second group, and I am one of them, is trying to learn from their mistakes. If we don't look at our errors and try to avoid them, what sort of progress are we going to make on improving reliability? Trying to do a failure analysis on a bearing such as that shown in Photo 10.18 is largely a waste of time!

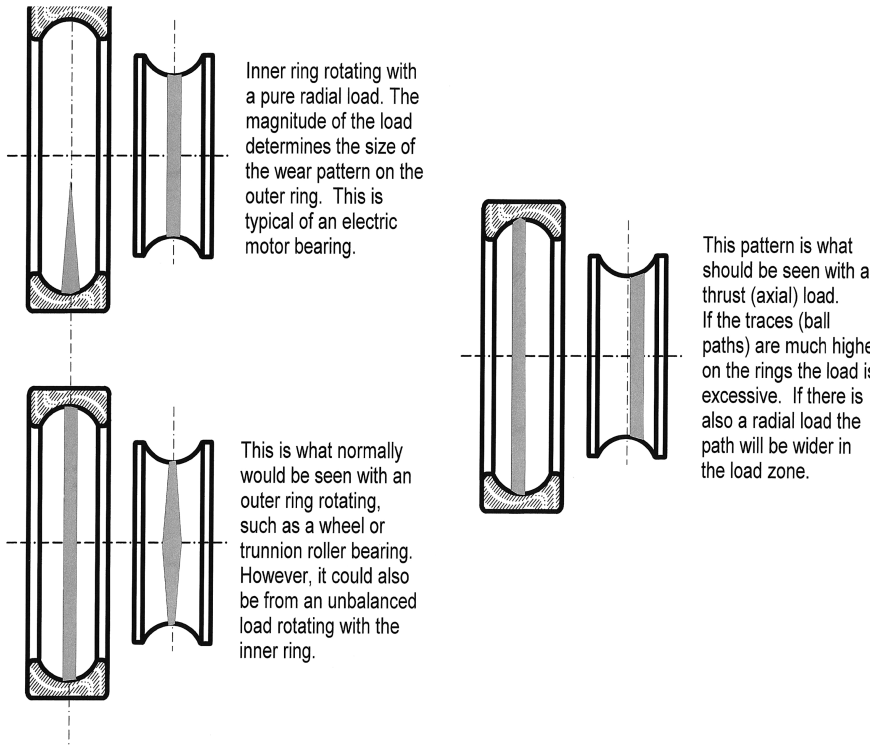
FIGURE 10.5 A series of normal ball paths (traces) showing some typical ones to expect.

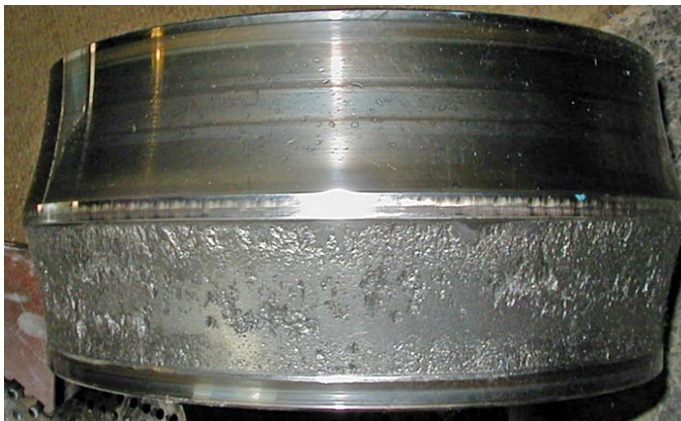
PHOTO 10.19 A spherical roller bearing with a tremendous thrust load, something for which it is not designed.

that the one path is carrying the entire load. Photo 10.19 shows the outer ring of a spherical roller bearing that was installed with no end float, i.e., the bearings were on a fan and both bearings were fixed so they couldn't move when the shaft expanded and contracted, and it is obvious from the photo that one ring carried the entire load.

- v. (If the damage happens during the manufacturing process before the bearings are finish ground, surface imperfections are called “dents”.) The dings and damage in the upper roller path of Photo 10.19 are bruises.

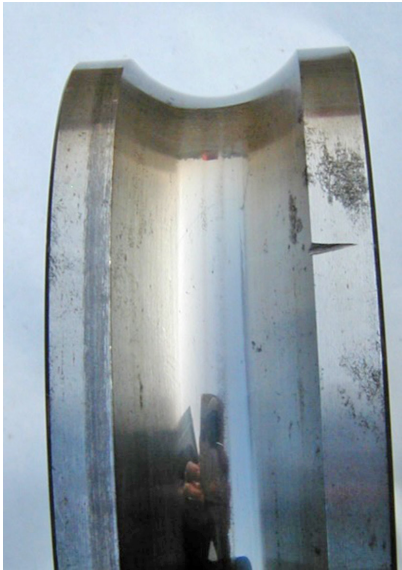
PHOTO 10.20 This shows an extremely shiny and polished ball path, the result of skidding. Look closely at the center of the path, in line with the horizontal mark on the right side of the ring, and some scarring is visible.

- i. Black marks or spots – Indicate that water or corrosives have been present.
 - ii. Highly polished – This mirror-like appearance is the result of skidding and may be caused by inadequate lubricant film and/or water contamination. Photo 10.20 shows a ball path that looks like a mirror and a careful inspection shows my digital camera. This was a bearing that was started without lubricant. It was greased after about three hours but the damage was already done. (The wide ball path is a symptom of other problems.)

- Photo 10.30 is actually the same bearing as seen in Photo 10.20 where the excessive end thrust overpowered the lubricant.
- Photo 10.31 is a good comparison of the differences between the shallow *surface fatigue* on the left and deeper *Hertzian* fatigue on the right.
- *Irregular “patches” of spalling* – A combination of forces. In the example Photo 10.32, it is a combination of false brinelling (or brinelling) and lubricant breakdown. It could also have been one of them combined with shaft or bore eccentricity. (Also notice that there was no load on the other ball path.)

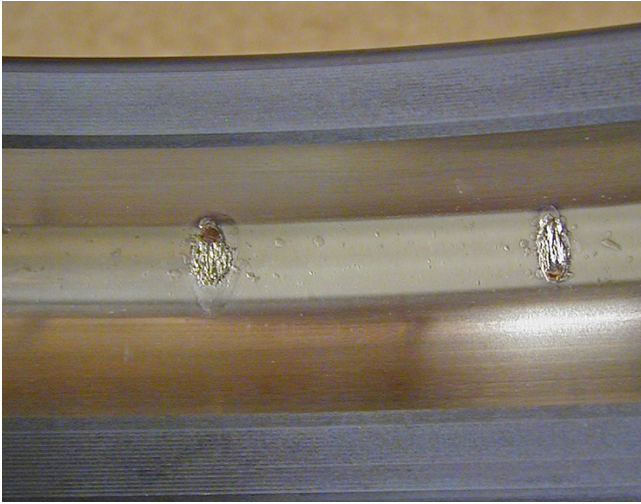
PHOTO 10.23 Two narrow spalls in a ball path that looks etched from the debris being rolled along it. (This appearance would make me suspect false or true brinelling or electrical damage, but further analysis would be needed.)

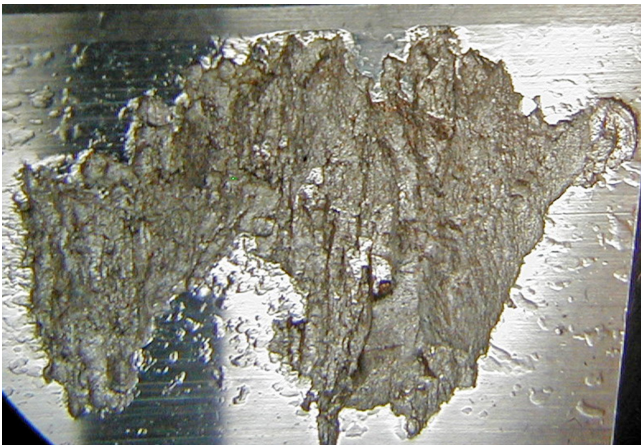
PHOTO 10.24 A deep and irregular Hertzian fatigue spall.

- *Single small deep spall* – Typically the result of Hertzian fatigue, arcing from high amperage electrical current passage, or a single external blow. Photo 10.24 shows a Hertzian fatigue failure of a roller bearing. The spall began below the surface on the far right and grew to the left as pieces flaked out of the surface. Photo 10.25 also shows a Hertzian fatigue spall but this one is in the outer ring of a deep groove ball bearing. For both of these bearings a major clue that they are from Hertzian (end of life) fatigue is the relatively deep nature of the spalls.

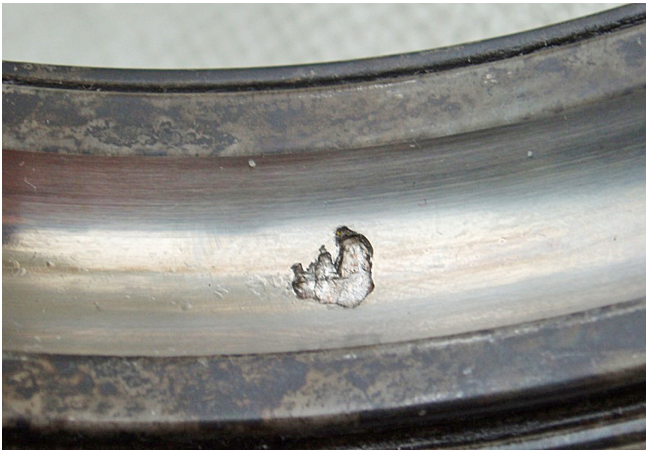
PHOTO 10.25 A single Hertzian fatigue spall. Metallurgical analysis may be needed to understand exactly why it started here.

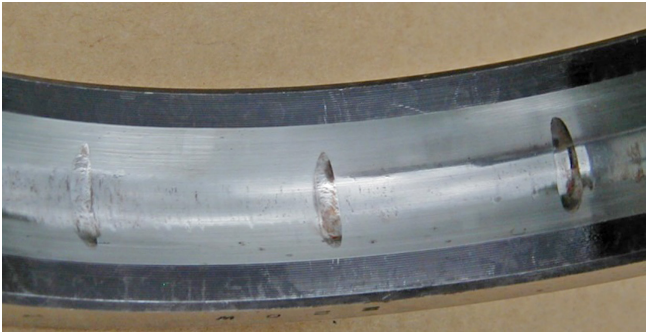
PHOTO 10.27 Brinelling happens with a single blow. False brinelling is the result of tiny vibrations over a long period of time.

- The first, Photo 10.26, is a forklift truck spindle where the mechanic has misaligned and driven the bearing onto the shaft. When a bearing is *brinelled* the impact of the rolling elements being driven into the ring results in a series of dents that rapidly lead to multiple spalls.
- The second, Photo 10.27, is a view of a bearing with false brinelling. Brinelling is a denting process that happens in a single blow. *False brinelling* happens over time and is actually a welding and corrosion process that removes material

from both the ring and the elements. In this example the outer ring has multiple depressions from *false brinelling* and if it had continued to run it would have failed rapidly.

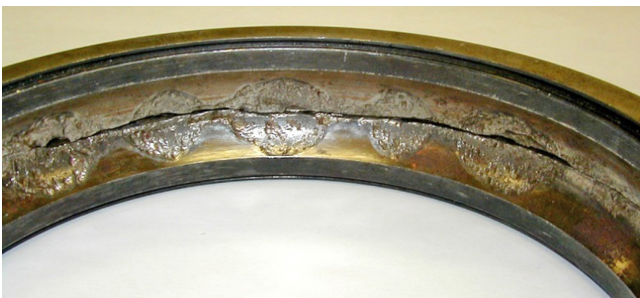
PHOTO 10.28 If we didn't know what had happened, it would be essentially impossible to tell if this damage started from true or false brinelling.

- Photo 10.28 is of a pump bearing that shows advanced damage. Once a bearing has run for a while it is almost impossible to tell the difference between *brinelling* and *false brinelling*. (To get this example, we accidentally dropped a 500 kg [~1100 lb] pump while rigging it into position. It fell about six feet and landed on the shaft, and we were worried that we had brinelled the bearing. We didn't have a spare and put it in run, but vibration analysis on the unit immediately indicated that there was a problem. The pump ran for about nine months before it was removed from service on a planned outage.) The photo shows the regularly spaced damage that started with the brinell marks but has been multiplied by water contaminating the lubricant, resulting in many shallow spalls.

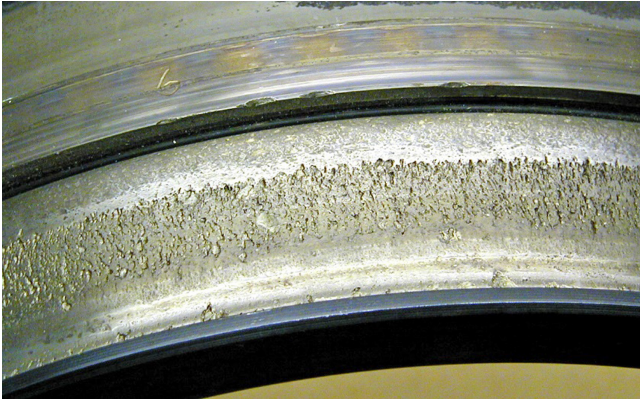
PHOTO 10.29 An excellent example of surface fatigue where the cracking starts on the surface and grows inward.

- Photo 10.29 shows one path on a double row spherical roller bearing and the fine peeling is typical of a bearing with a

serious lubrication problem. In this example the lubricant was contaminated and couldn't do the job.

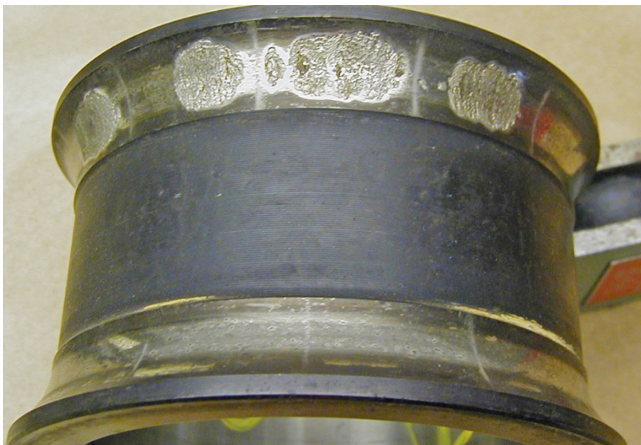
PHOTO 10.32 A real challenge and the diagnosis would have to depend greatly on the location and operating practices. The thrust loading is obvious. The surface fatigue spalls may have started from true or false brinelling. Further analysis is needed.

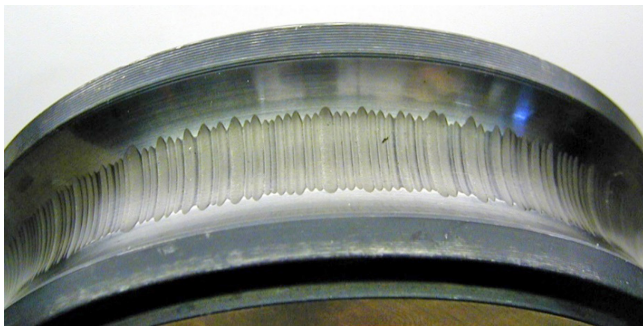
PHOTO 10.33 A bearing from a motor controlled by a VFD showing the later stages of *fluting damage*. The fact that this ball path is extremely wide states there were other problems.

Before we go on to Step 6, we should discuss the effect of electrical currents on the ball path appearance. A common occurrence with low amperage, high voltage current leakage across the element path is *fluting*. Photo 10.33 shows an example of fluting in a 150 kW (200 hp) 1800 rpm motor bearing. The individual lines are caused by electrical arcing and remelting of the bearing steel.
