PRACTICAL PLANT FAILURE ANALYSIS

A Guide to Understanding Machinery Deterioration
and Improving Equipment Reliability

Neville W. Sachs, P.E.

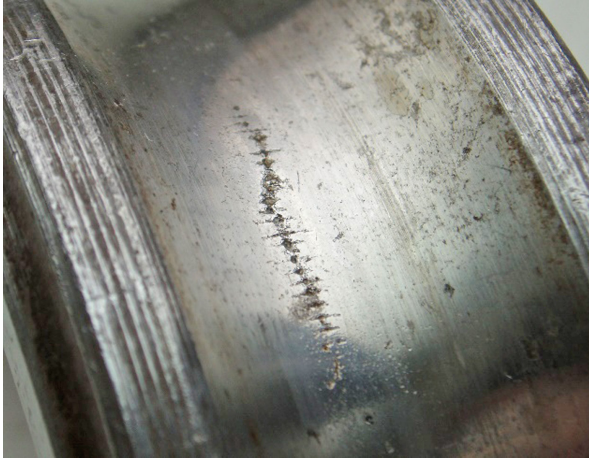
PHOTO 10.36 This is arcing damage from welding currents going through the bearing do to an improper ground, and the individual arc strikes show it's an AC welder. (To avoid this, it is critical that the welder be grounded close to the site of the welding. Using “building grounds” tends to cause these failures.)

Photo 10.36 shows second type of electrical damage that is usually seen as a result of improper grounding during welding. The typical situation involves a welder not grounding close to the weld and a second ground path allowing flow through the bearing. The crew was welding on a pipe connected to a running pump and the resultant arced pits show each pulse of the AC welding current.

1. This type of damage can also occur during other high voltage, high amperage electrical abnormalities.
2. This bearing also shows contamination and corrosion damage.)

If the welding shown in Photo 10.36 had been done while the machine wasn't running it is likely that the elements would have been welded to the rings and we have seen several examples of that.

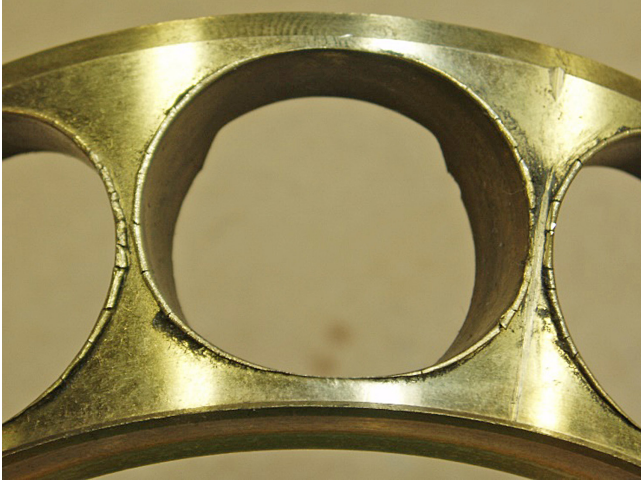
PHOTO 10.38 The plastic deformation of this battered cage proves it has seen grossly excessive loads and the lubricant hasn't been able to properly protect the cage.

- iii. However, if there is substantial wear, plastic deformation of the edge of the cage, or a cage fracture, it indicates there are either substantial reversing loads or poor lubrication. (These reversing loads generally occur only with torsional vibration and are a common problem source.) In Photo 10.38 this angular contact ball bearing cage shows tremendous plastic deformation. There are two obvious

problems, the bearing was so heavily loaded the lubricant film broke down and there was a serious torsional vibration in the drive.

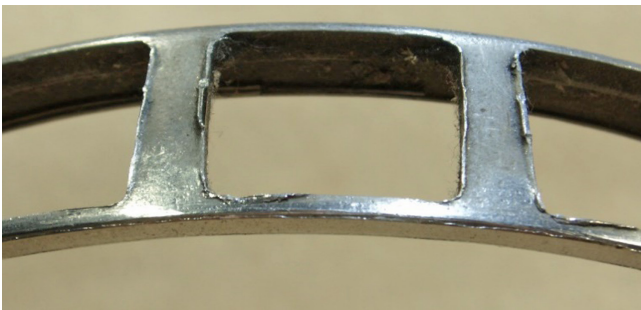
PHOTO 10.39 Another plastically deformed cage indicating either lubrication problems or excessive loads.

No – The bearing rollers are not rolling correctly. Either the lubricant film is inadequate or the geometry is incorrect. Photo 10.39 shows a spherical roller bearing cage. If the bearing had experienced pure

radial loads the cage might be slightly worn on the cage bars. But this cage shows heavy wear on both side of the pocket as well as wear on the near side of the pocket. This combination of symptoms shows there are serious lubrication problems and possible reversing loads during each rotation.

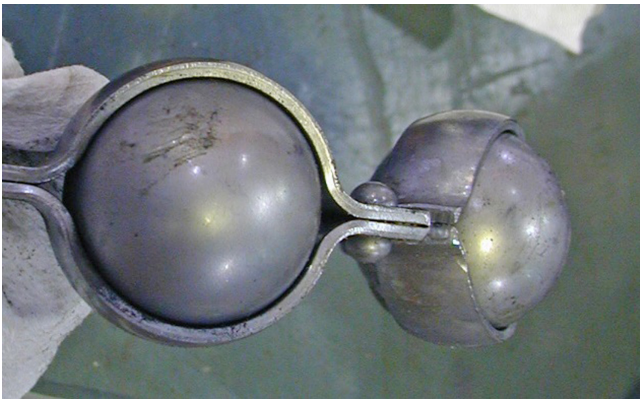
PHOTO 10.40 The black spots are corrosion caused by water in the bearing. (One of the major problems resulting from corrosion of hardened steels is hydrogen damage.)

- Black spots and/or blackened grooves – The black stains are corrosion products and indicate water has been present when the bearing wasn't rotating. The black smears on the balls in Photo 10.40 are proof that water has been present.

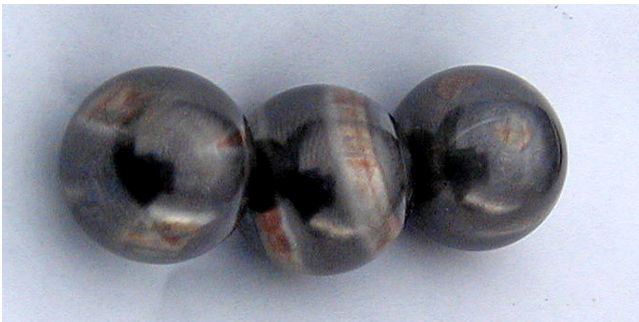
PHOTO 10.41 These three balls were pinched between the two rings so they couldn't rotate freely. This is most often the result of the inner ring fit being too large.

- Fine circular scratches – These usually result from hard debris particles caught between the ball and the cage.
- Discolored circumferential bands – Typically the result of inadequate clearance between the inner and outer rings. The bands form when the balls can't freely rotate as shown in Photos 10.41 and 10.42.

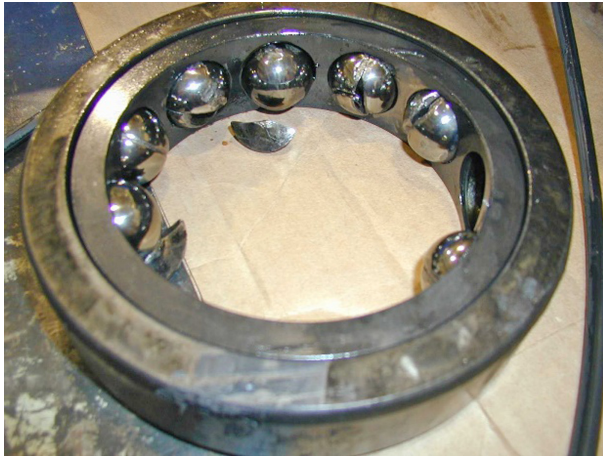
PHOTO 10.42 If the internal interference is even worse, the rolling elements frequently shatter like the ones shown in this photo. (The replaced motor shaft bearing fit was significantly oversized.)

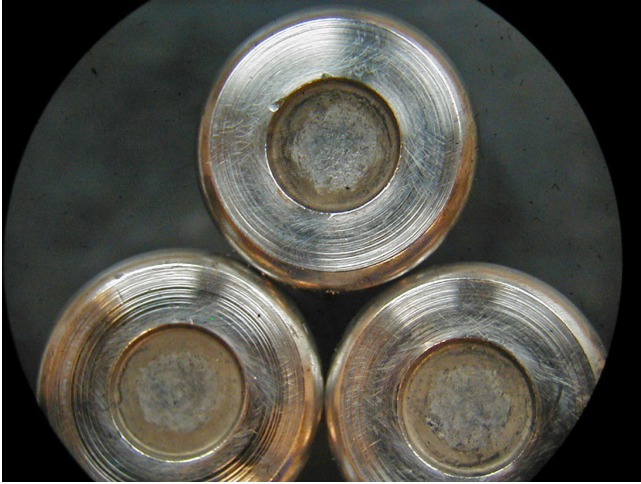
PHOTO 10.43 This photo and the next show damage to the ends of the bearing rollers that shouldn't be happening. Either the load is excessive or they are using the wrong lubricant.

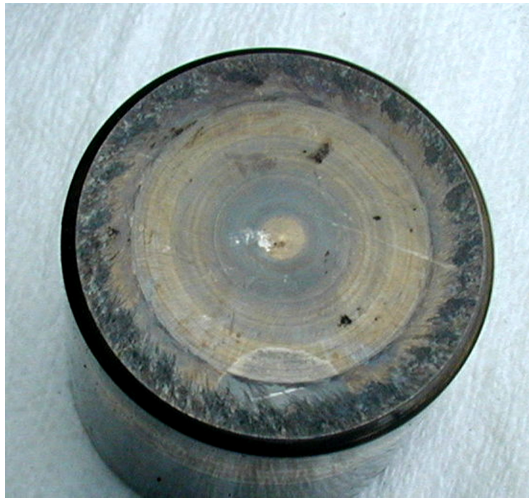
PHOTO 10.44 The swirl pattern on the ends of the bearing rollers shouldn't be there. Again, either the load is excessive or they are using the wrong lubricant.

Comment – Highly polished roller ends with circular score marks or “semicolons” on them as shown in Photos 10.43 and 10.44, show that

either substantially elevated thrust loads or very poor lubrication has occurred. (Rollers are not made with pretty swirl patterns on them.)

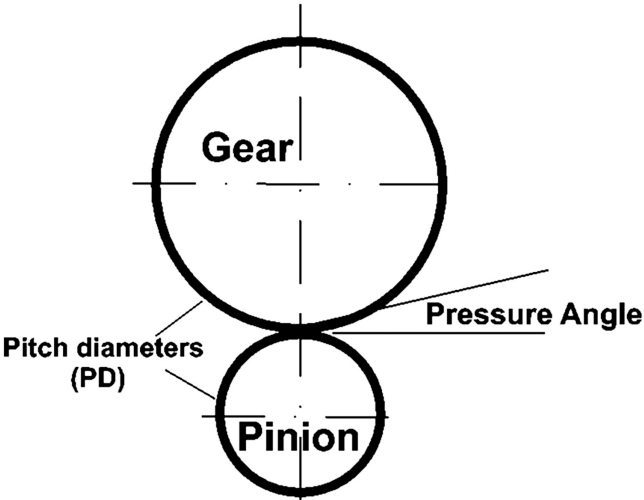
FIGURE 11.2 Shows the pressure angle of a pair of gears.

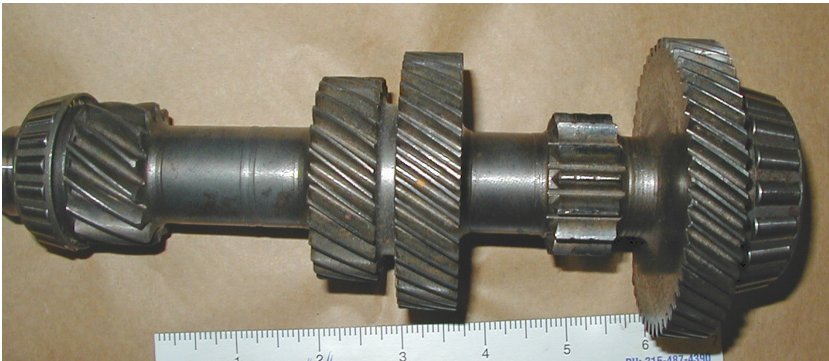
PHOTO 11.1 This is a “cluster gear” from a four-speed automotive transmission. The small spur gear is reverse.

Photo 11.1 shows a “cluster gear” assembly from a manual automotive transmission. There are the four helical gears used for forward speeds while the one spur gear is reverse. (A second interesting feature of this assembly is the difference in the size of the tapered roller bearings, partially a result of the point where the load is delivered but largely the result of the thrust force produced by the helical gears.)

The “cluster gear” shown in Photo 11.1 was the source of a very practical gear metallurgy lesson for me. It happened in one of our cars shortly after the car was out of warranty and, as you can understand, I was more than a little frustrated. It pulled the gear out of the transmission and took it to a friend of mine who was the chief metallurgist at a local gear manufacturer and the second I showed it to him I knew he was also frustrated. His company had made the gear and their analysis found:

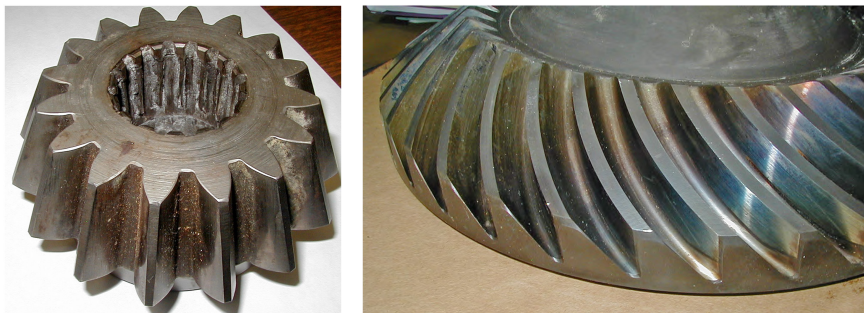
PHOTOS 11.2 AND 11.3 A bevel gear on the left and a spiral bevel gear on the right.

Spur, herringbone, and double helical gears have to be used with parallel shafts. Also, most helical gears are used with parallel shafts but there are many other gears designed for use on non-parallel shafts. Two of these are shown in the photos while others are described in the text.

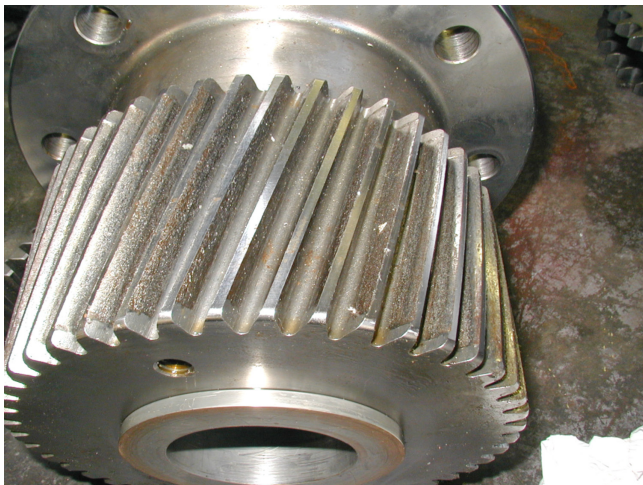
PHOTO 11.4 This gear drives in one direction, but there is wear on both sides of the teeth. That tells us that the teeth are seeing loads more than twice what the gear was designed for.

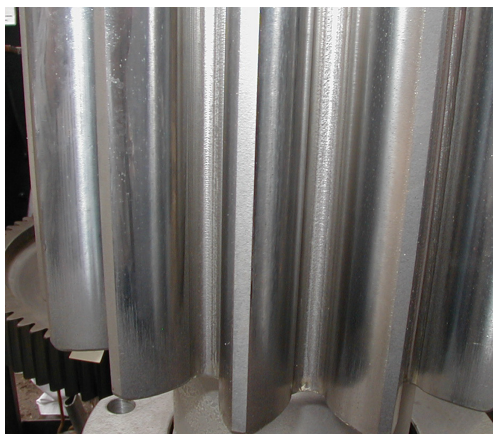
PHOTO 11.6 This is the drive pinion from a haul truck wheel motor and it really emphasizes what happens with structural deflections. These haul trucks were pulling heavy loads up out of a mine, then the 300 +/- ton trucks were coasting downhill to be refilled. The difference in wheel motor stresses flexed the housings to the point where the two sides of the teeth couldn't both be in perfect contact. We often see similar alignment challenges in mobile equipment such as draglines and bucket loaders.

With through hardened gears misalignment such as that in Photo 11.5 frequently appears as pitting after only a short time in run. With a surface hardened gear, such as the haul truck drive pinion shown in Photo 11.6, there should be no visible damage and it is more difficult to see. In this example, the contact pattern that ends well before the edge of the pinion tooth shows that the peak contact and bending stresses are well above two times the ideal design stress.

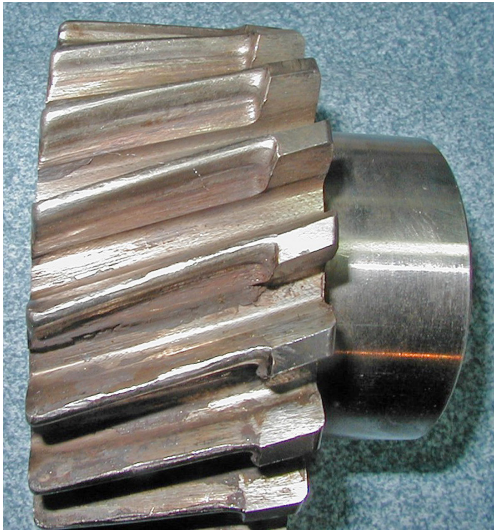
PHOTO 11.7 A badly worn “through hardened” gear that actually wasn’t hardened at all. Testing showed it was machined from SAE 1045 steel and was about BHW 180.

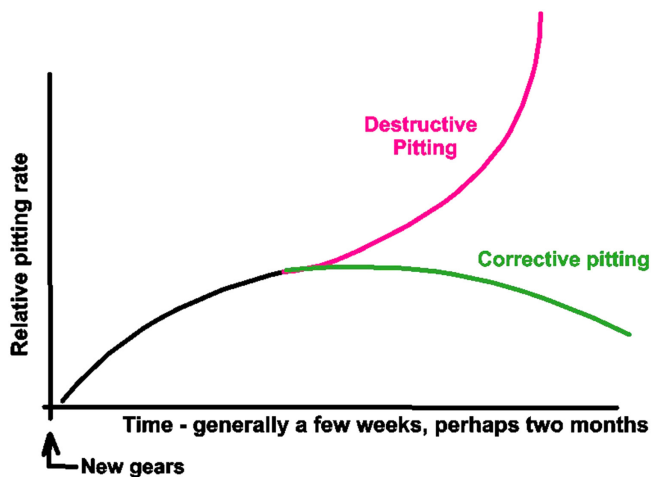
FIGURE 11.11 Corrective pitting should gradually grow across the width of the through hardened teeth and then the pitting rate should decrease.

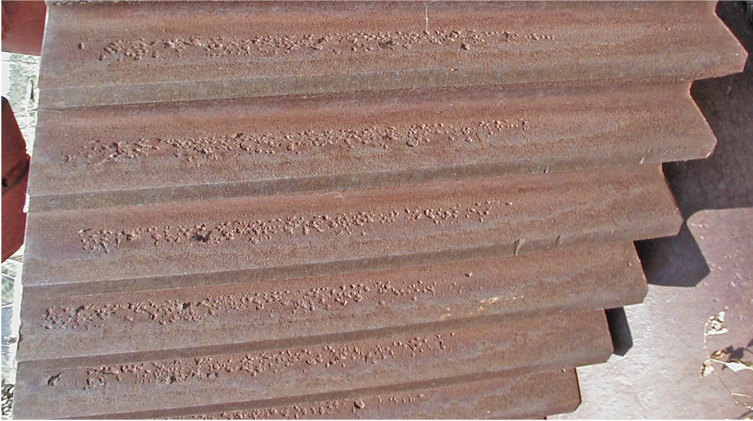
PHOTO 11.10 An example of corrective pitting. As the pits grow across the teeth and the contact extends over more and more area, the wear rate slowly decreases. Unfortunately, in this example, the rust will decrease the gear life.

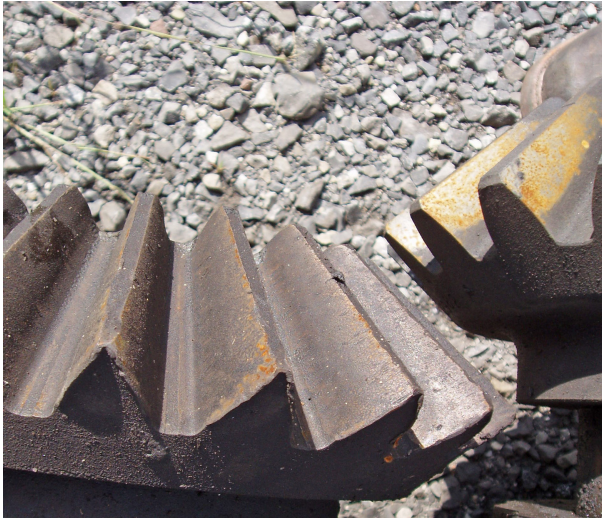
PHOTO 11.11 The gear on the left shows rolling where the tooth metal has been pushed up over the top and over the sides of the teeth. It's also heavily worn.

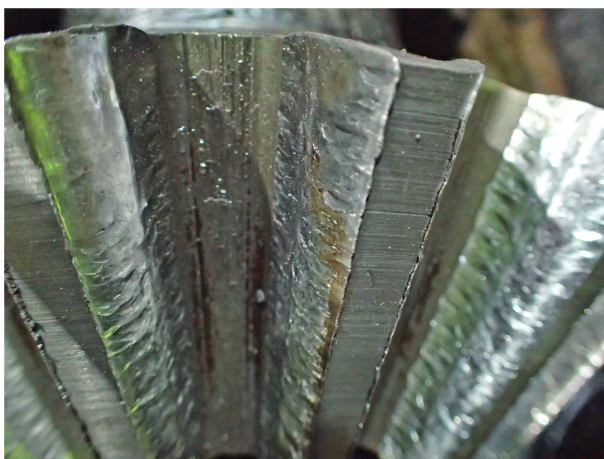
PHOTO 11.13 A much more serious example of adhesive wear. In this example, a bearing on this reversing application reducer failed and put an extreme load on the teeth and lubricant. The lubricant couldn't do its job and result is severe adhesive wear and rolling of the teeth material.

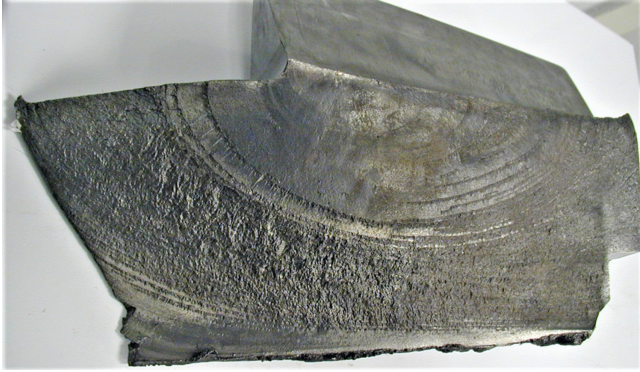
PHOTO 11.14 A cast steel through hardened gear that was relatively new. Inspection of the fracture face can tell us that the tooth was poorly aligned and that it failed from fatigue (repeated loads). Also, the extremely large instantaneous zone tells that the final fracture load was extreme.

Gears fail from fatigue much as the other mechanical components and Photo 11.14 is an interesting example.

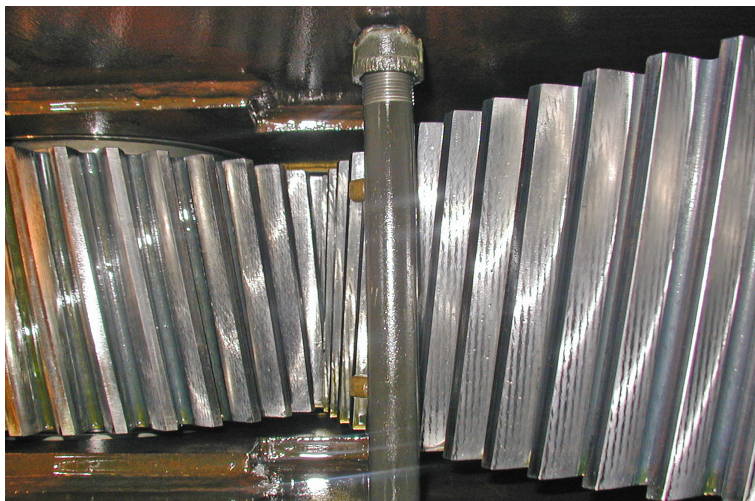
PHOTO 11.15 If you could look at the micropitted lines on these teeth under high magnification, you would see a series of extremely fine pits, as though they were sandblasted.

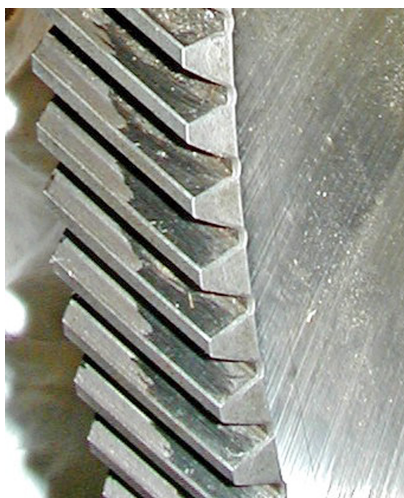
PHOTO 11.16 This centrifugal compressor drive gear was installed improperly and was misaligned with a heavy load on the left side of the teeth.

In many situations however micropitting is cause for concern as is shown in the two examples below. Photo 11.16 shows a 3.2 cm (≈ 1.25 in) wide centrifugal air compressor drive gear with micropitting on the left side of the teeth while Photo 11.16 is of a gear from a small generator drive that shows micropitting on the right side. In both applications the fact that the attack is concentrated on one side and is relatively obvious indicates serious alignment problems and, looking at Photo 11.17, the

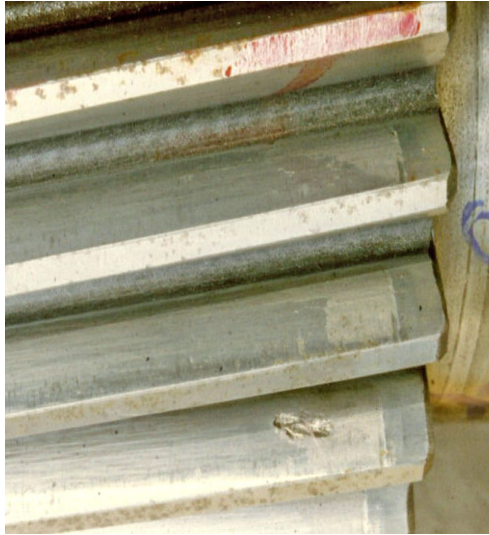
PHOTO 11.17 This is micropitting on the upper two teeth followed by a pit on the lower one. This sort of micropitting, i.e., when it is on one side of the gear, should ALWAYS be a cause for concern.

micropitting has developed into macropitting and there is a pit on the lowest tooth in the photo.

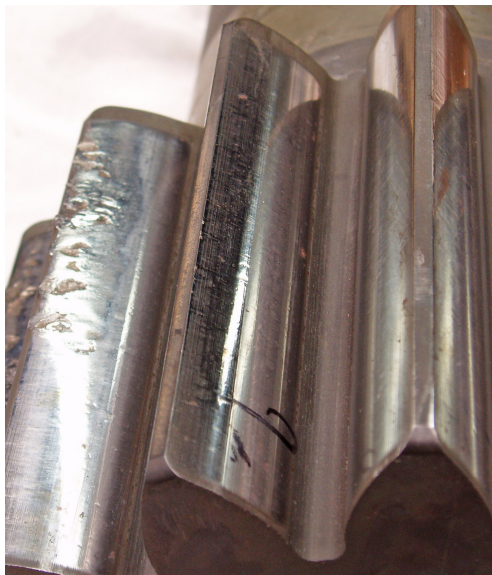
PHOTO 11.18 The tooth on the far left shows rippling, a situation in which the load is heavy enough to deform the hardened case and an indication that the gear is very heavily loaded. Also, the loading on one side is proof that there is an operating misalignment.

With the knowledge that micropitting shows there are heavy loads, any *macro* pitting is source of serious concern. Having said that we should emphasize that pitting can't automatically be considered a warning of an impending disaster, but it does have to be carefully analyzed along the lines of any other failure (Photo 11.18).

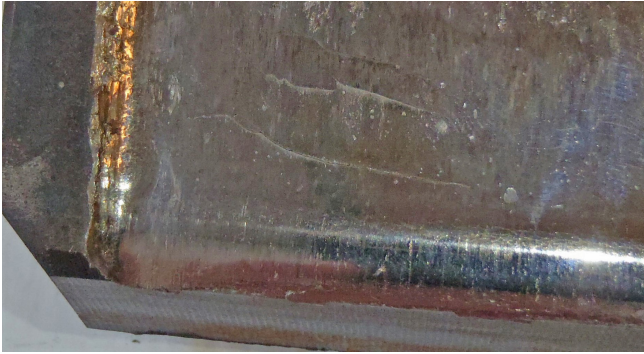
PHOTO 11.21 This is a close-up of a large tooth and the two cracks in the center of the picture are from case crushing, i.e., the brittle case cracked because the softer core deformed.

Photos 11.21 and 11.22 are both of some teeth that suffered from case crushing, sometimes called sub-case cracking. It happens when the load on the tooth is so great that it causes plastic deformation of the softer core. But the case is harder and less ductile than the core, can't tolerate the deformation, and fractures. The first photo

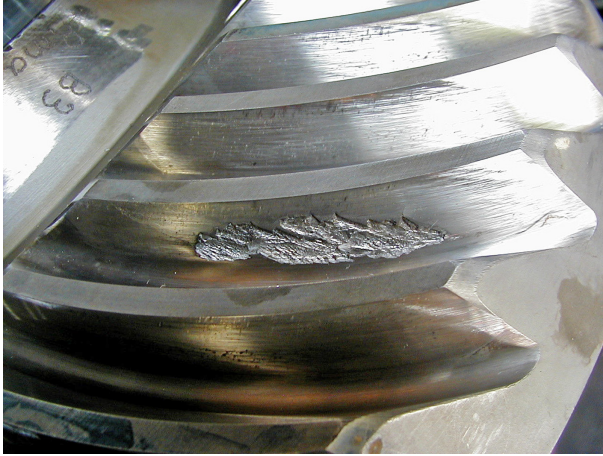
PHOTO 11.23 Spalling on an intermediate pinion.

This was a case hardened intermediate pinion on a reducer that had run for about a year. This is a three-stage reducer that was removed from service because of a vibration analysis indicating a problem. It had never been apart and the loads and speeds were well within the design specifications.

- Another spall about 120° around the case hardened intermediate pinion from where Photo 11.23 was taken.
- The lubricant tests indicated the lubricant was as specified by the manufacturer.
- Other than the two spalls there was no evidence of other damage or misalignment.

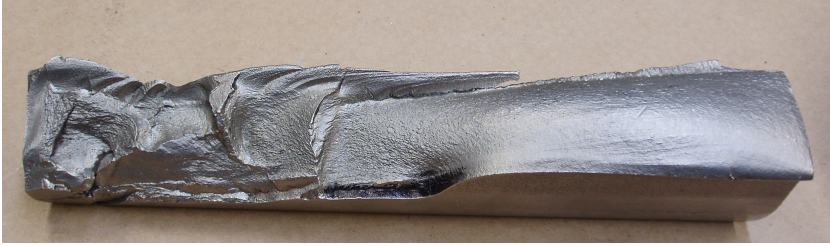
PHOTO 11.24 A case hardened tooth.

Inspection of the fracture face found, as shown in Photo 11.24:

- a. The tooth has a relatively thick case tempered to about HRC 52. (We have blackened the case surface in the bottom center of the photo.)
- b. The tooth failed from fatigue but, knowing that it has a relatively fine grain structure, the failure was very rapid.
- c. The load was poorly centered and the crack started far to the right side of the tooth and the left half of the tooth was the instantaneous zone.
- d. The wear pattern indicated the root clearance was excessive.

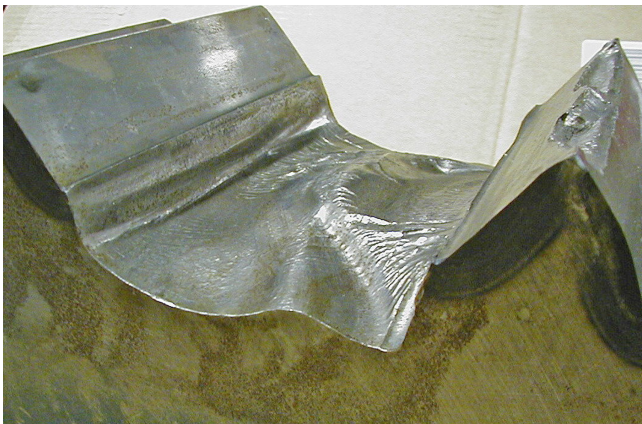
PHOTO 11.25 The pinion from a 2625 kW (3500 hp) pump drive reducer.

Photo 11.25 is of a 2625 kW (3500 hp) gear out of a pump drive that has two 1310 kW (1750 hp) 1800 rpm motors driving pinions that meshed with this gear. The output speed was about 400 rpm. This is a flame hardened tooth with a proprietary contour and the heat-treated profile is readily visible on the side of the teeth. The drive has been in operation for more than a year and there have been several comments from technical and maintenance personnel about gear noise.

Inspection of the fracture face shows that the gear is driven to the left while the river marks tell us that the crack growth is from left to right, against the drive forces. An inspection of the tooth surfaces shows there has been repeated contact on the “unloaded” side of the teeth.

Conclusion and recommendations – There was a torsional resonance in the gear teeth, i.e., the teeth were being struck or driven at a frequency that would excite their natural frequencies (confirmed by vibration analysis). The reversing forces put the weakest section of the case into tension, causing a crack that then propagated in the much weaker core section. As shown earlier in the chapter, for there to be contact on the unloaded side of the tooth, the tooth driving forces had to be more than twice the design forces. Changing the natural frequency of the gear and shaft assembly would be extremely expensive and we recommended they retire the reducer.

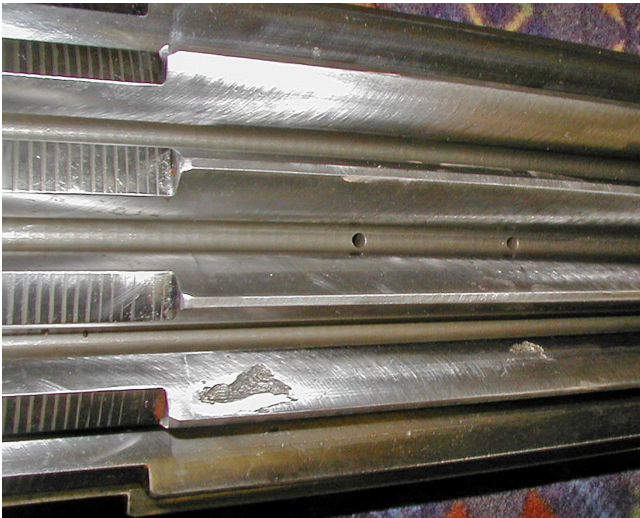
PHOTO 11.26 The pinion from a 300-ton haul truck.

Photo 11.26 is of a pinion from the rear wheels of a 300+ ton haul truck. This drive axle drives the truck uphill and is loaded on the other side by the braking system in the downhill run and it had been in operation about six months.

Conclusions and recommendations – The large size and unusual locations of the spalls lead us to suspect a materials problem possibly complicated by misalignment. We recommend:

- Carefully reinspecting this gear using wet fluorescent magnetic particle testing to determine if there is any more cracking. (This may show a more definite pattern.)
- Having a metallurgist section the tooth, analyze the metallurgy and the heat treatment.

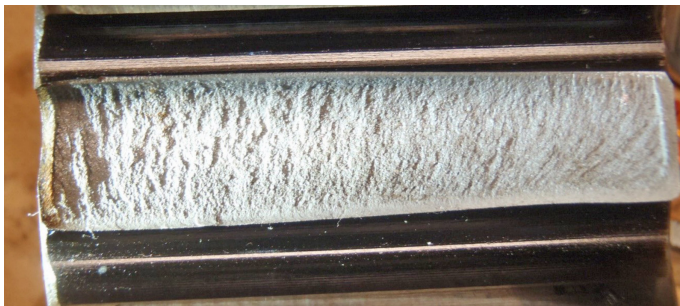
PHOTO 11.31 A relatively easy failure analysis, i.e., it broke instantaneously from an overload! Interesting is that the chevron marks show the fracture began about 20% of the way from the left side and prove that the alignment was very poor.

was evident that severe misalignment played the major role in causing the failure. However, the fracture photo below is a great example of the value of a simple field inspection. We've used a flashlight off to one side and shadowed the fracture face, similar to what was shown in Figure 4.3. From that it can be seen that:

- This was a brittle (instantaneous) failure.
- The gear is case hardened. (Notice how the outer layer is much smoother than the core.)
- The chevron marks are obvious and they point to the failure starting almost exactly one-fourth of the way from the left side of the tooth, proving that the alignment was very poor (Photo 11.31).

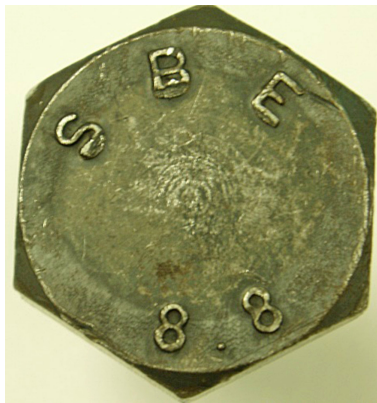
PHOTO 12.1 Both the manufacturer and the strength of the steel in this metric bolt are clearly stated on the bolt head with the 8.8 the tensile strength and yield strength multiplier and the SBE the manufacturer’s authorized mark.

General purpose metric bolts can easily be identified because they have their strength markings on the heads, always using a decimal point between the tensile strength value and the proof test multiplier. Photo 12.1 shows a metric bolt head and Table 12.2 shows a chart of the common metric fastener designations along with the comparable SAE and ASTM standards. The first number on the head shows the tensile strength in hundreds of megapascals while the number after the “.” is the proof test multiplier. In the photo, the 8.8 shows a bolt where the tensile strength is approximately 800 megapascals (MPa), the proof test multiplier is 0.8, and the resulting proof strength is approximately 640 MPa. The SBE on the bolt head is the manufacturer’s trademark and, looking in the *Fastener Technology International* database, the manufacturer is Societa Bulloneria Europa SPA from Monfalcone in northeastern Italy.

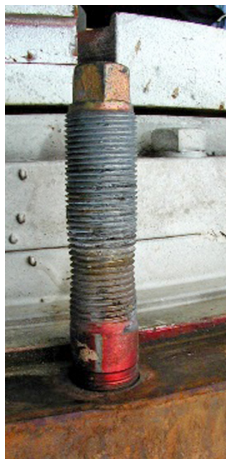
PHOTO 12.2 This is a bolt from a wheel motor on a 240-ton haul truck. To ensure consistent clamping force on the motor components, the bolt yield strength has been slightly exceeded.

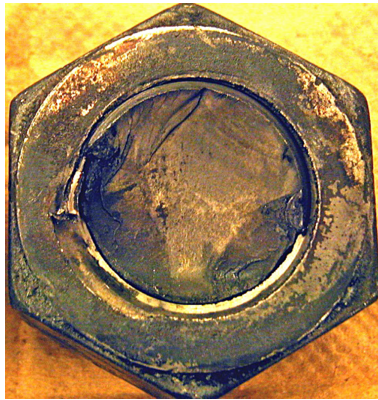
In a similar manner, the piece shown in Photo 12.4 is a nut and a failed bolt. The fracture was the result of a fatigue crack starting at about the 1:30 o'clock position. The contact surface on the underside of the head shows two polished areas, one at about 10:30 o'clock and one at 2:00 o'clock. The only way these surfaces could have

PHOTO 12.4 A fatigue failure, but the interesting point is the irregular contact on the nut surface.

become polished during operation is if the mating surface was irregular and there was movement between the two pieces.

One of the contributors to the failure in Photo 12.4 was the irregular contact surface and the importance of a well lubricated, smooth contact cannot be overstated. After a bolt is tightened, over time it will normally lose a portion of its clamping force because of minute smoothing of the asperities and plastic deformation. If the contact area is small the forces can be extremely high and there may be substantial plastic deformation.

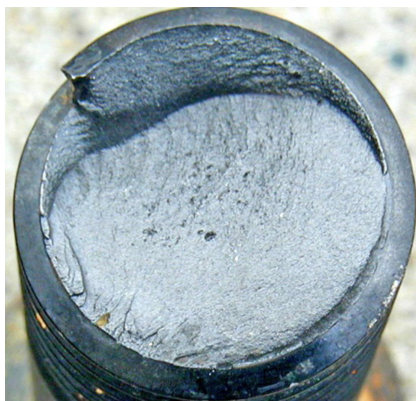
PHOTO 12.E1

Inspection – A close examination of the fracture origin, centered at about 7:00 o'clock, shows some small corroded and discolored pits. The fracture surface is uniform in smoothness up to the shear lip that runs from about 3:00 o'clock to 9:00 o'clock. (Shear lips are common on tension failures and occur when the crack changes direction as it grows across the piece. This change in direction happens because the load center is no longer in the physical center of the piece.) Shadowing the fracture surface, it can be seen that there are a series of chevron marks that point toward a relatively broad origin. Examination of the contact surface of the head showed no polishing, fretting, or other evidence of movement.

Conclusions and recommendations – This is a brittle overload failure and happened as the load was applied. We recommended that a metallurgical examination of the bolt be conducted before any other action. This would determine if the fracture was influenced by hydrogen damage. Whether it was or not, look at the operating practices to better understand the impact loading and why it occurs. If corrosion influenced the failure a specially coated bolt should be considered (Photo 12.E1).

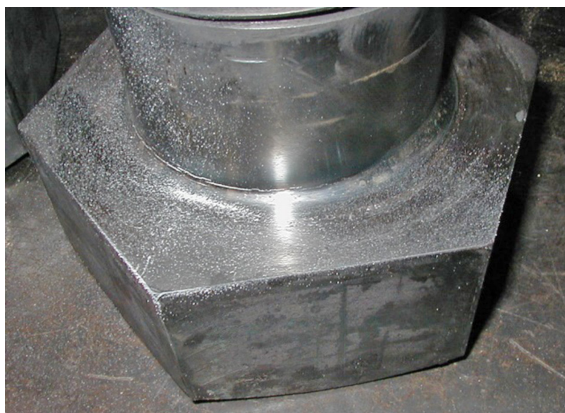
PHOTO 12.E4

Photo 12.E4 shows cracking in the underhead radius of one of a group of 610 mm (~2.5") bolts that anchor the lower die set of a 500 ton forging press. The press runs in a heated and controlled atmosphere and does not see the environmental variations

of the previous example. There are eight bolts that hold the die set in position and we had been asked to nondestructively test several sets of them. They had been using a hydraulic torque wrench to tighten the bolts.

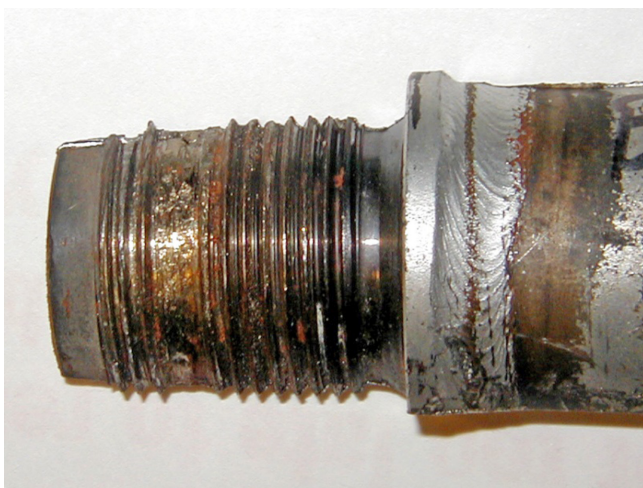
PHOTO 12.E6

This is an igniter from a large gas engine and is similar to a spark plug used in a typical automotive engine. The site had many of these engines and when an igniter failed they had to be replaced. However, frequently during attempts at removing the old igniter, the threads would seize and gall, requiring lengthy and expensive repairs. The problem had not been seen with the OEM igniters but these were a less expensive replacement and not quite the same construction.

Inspection – The inspection found the threads were essentially being welded into position and this galling is not uncommon on assemblies that see severe temperature cycling. Hardness testing of the steel male and female thread assemblies found they were of the same hardness.

Conclusions and recommendations – The igniters were galling because of the compatibility of the materials when subjected to heat and pressure. We suggested they could go back to the OEM igniters or they could speak with the new supplier and ask that they change to a harder threaded body and consider a thread coating that reduced the probability of welding to steel (Photo 12.E6).

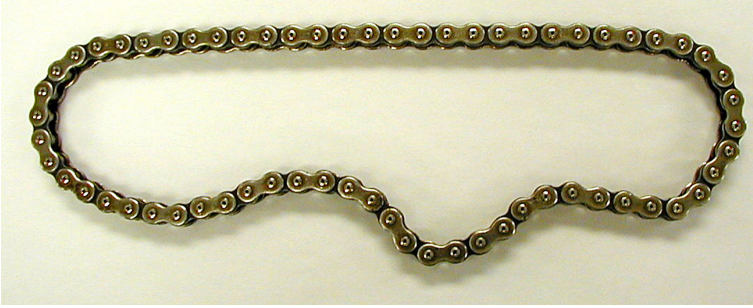
The chain wears every time it flexes and a chain with a lot of slack and frequent turns, as shown in Photo 13.1, will wear out much more rapidly than one with only a slight sag.

PHOTO 13.1 This roller chain has been taken off the sprockets, but arranged in a manner so the “waves” in the bottom of the photo duplicate its appearance during operation. The chain was loose and at every change in direction additional wear took place.

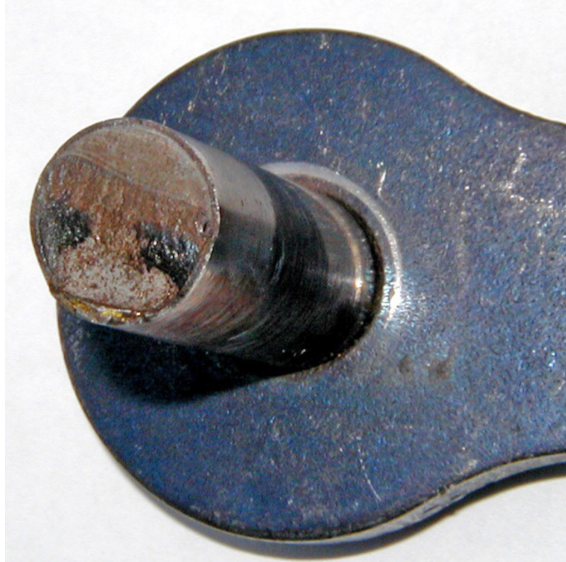
PHOTO 13.2 The fatigue failure of a case hardened chain pin. The origin is at the top and there are obvious progression marks heading toward the relatively large IZ. This failure was the result of gross misalignment.

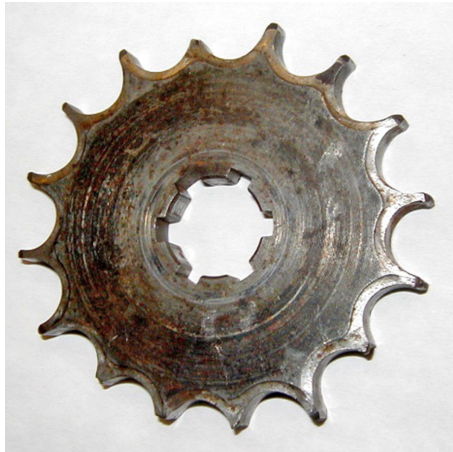
PHOTO 13.3 This badly worn sprocket came off a dirt bike and, because the wear changed the effective center distance of the teeth, destroyed the chain in less than five hours.

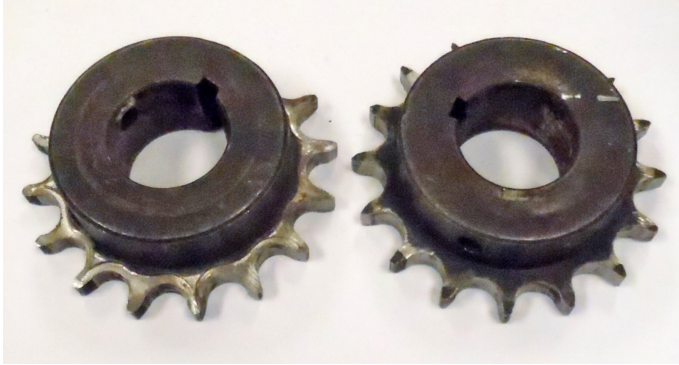
PHOTO 13.4 Look at the wear on the sides of the teeth on these two sprockets from an industrial drive that was horribly misaligned. This drive ran for only two weeks and eventually broke the chain.

5. Cotter pin failures are essentially always the result of misalignment. (Cotters are designed as keepers to hold the pieces in position and are not supposed to be subjected to substantial thrust [side] loads.) (See Photo 13.4.)

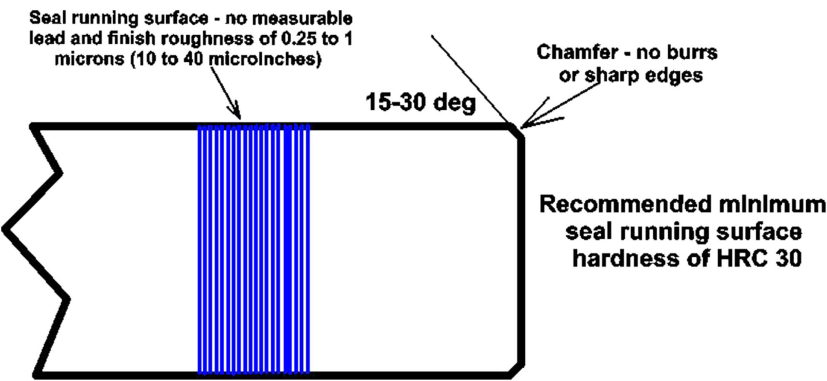
FIGURE 13.2 Typical recommended surface conditions for effective shaft and seal life.

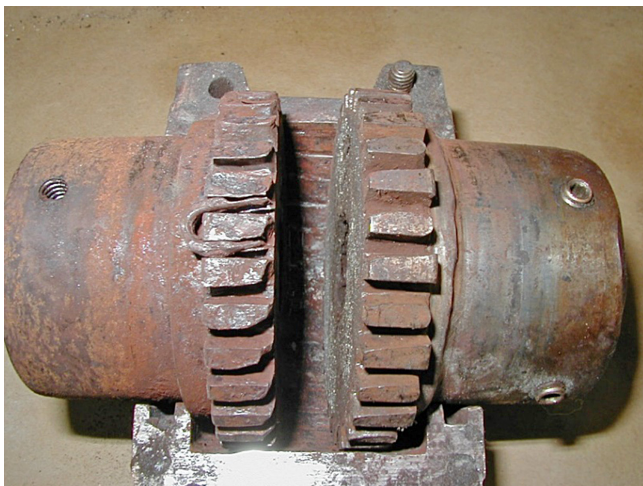
PHOTO 13.6 This coupling is a disaster in several respects as the text mentions. One of the interesting clues to the skill and direction of the workforce is that there was no sign of the rubber gaskets that should be on the hubs.

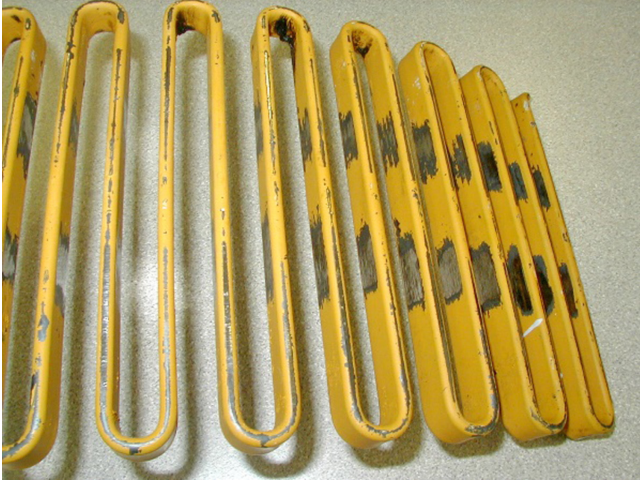
In contrast to the disaster mentioned above, look at the coupling grid in Photo 13.7. This was in operation on a skip hoist for about nine months and appears to be in excellent condition but still tells an interesting story as follows:

1. The wear patterns are a little heavier on one side than the other, suggesting that the drive forces may not be quite balanced in both directions.
2. For nine months of operation the amount of wear is very small and the coupling is well lubricated.
3. The polishing on the top of the grid shows it is rubbing against the cover and the coupling is misaligned.

PHOTO 13.7 This is what a coupling grid should look like, except look at the polishing on the top of the grids, the result of misalignment. (Using a specialty coupling grease, we once ran a grid coupling for six years at 1200 rpm and it looked about like this one when we finally removed it!)

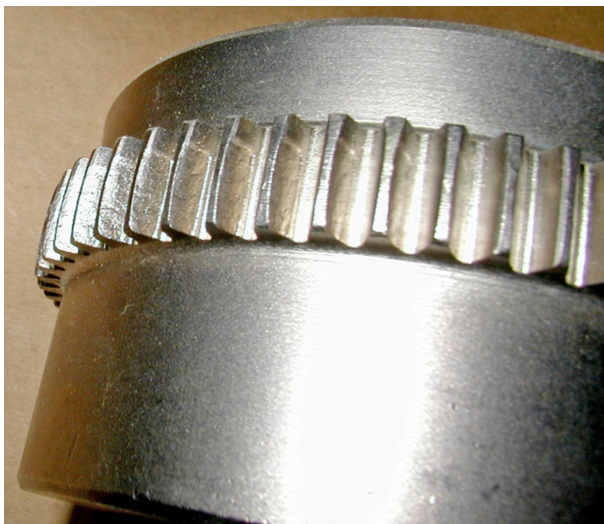
PHOTO 13.9 The “killer coupling” that, in only four months at 3600 rpm caused the death of the motor and the compressor – because it wasn’t properly aligned. The wear on the teeth is a combination of poor lubrication and misalignment.

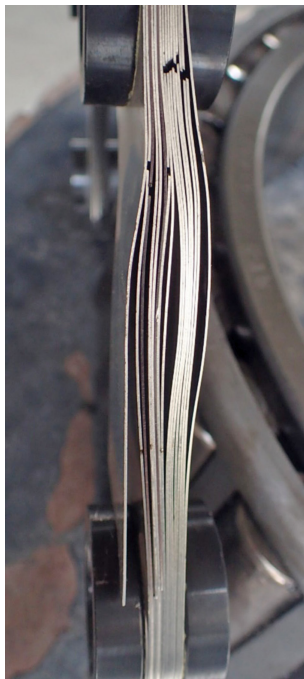
We have seen the occasional coupling with disks fatigue fractured like the ones in Photo 13.10. Those couplings have usually seen some misalignment, although we worked on one in a nuclear power plant where there was a tremendous torsional resonance that visibly flexed the disc pack.

PHOTO 13.10 This shows some broken disks, the result of repeated fatigue forces from misalignment, although they could also be caused by torsional vibration in the system.

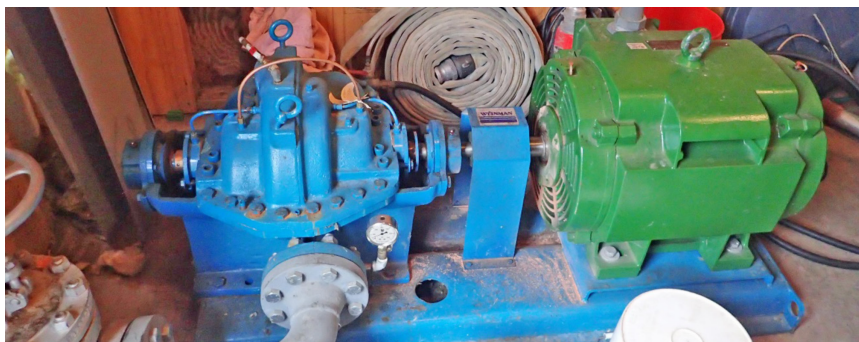
PHOTO 13.11 The orange dust under the coupling and on the motor vents has been ground off the teeth of the polymer insert by serious misalignment.

Misalignment is another common problem because too many mechanics feel that, because they have flexible elements, there isn't the need for good alignment. Photo 13.11 is of a 75 kW (100 hp) water pump and the orange dust beneath the coupling has been worn off the teeth of the T.B. Woods coupling insert. (In operation, you can tell if the damage is from misalignment or torsional vibration by looking at the coupling with a strobe light. If the two hubs can be frozen at the same time, the problem is from misalignment.)

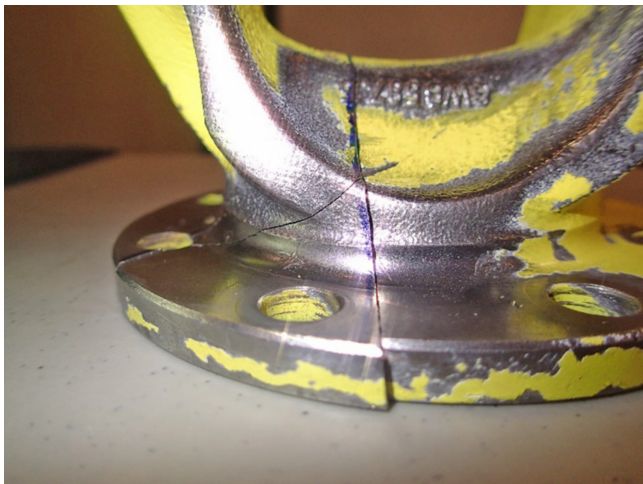
PHOTO 13.12 A fast growing fatigue crack in a steel Cardan joint yoke.

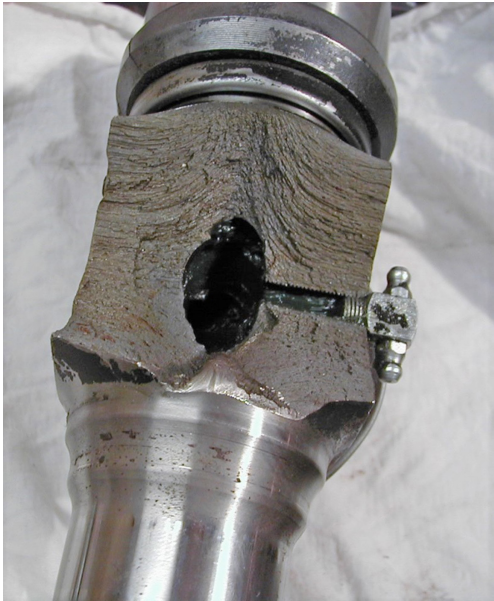
Photo 13.13 is another failure but this one is a classic case of an instantaneous brittle overload, with some tremendous chevron marks that point to the failure starting at journal at the top of the photo.

PHOTO 13.13 Another U-joint failure off of a paper machine, but this one was instantaneous.

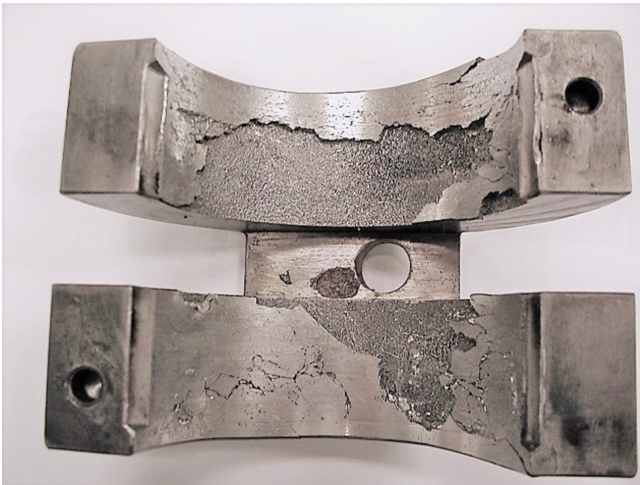
PHOTO 13.14 This is the upper half of a ring-oiled motor bearing. Note how, in what should have been the unloaded side of the bearing, the babbitt has cracked out because the bond was defective.

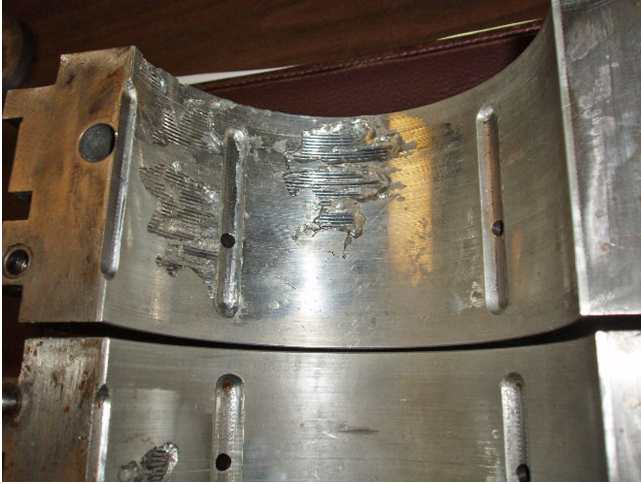
PHOTO 13.15 This is the lower half of a fan bearing and the upper is barely visible at the bottom. Note how the babbitt has cracked out of the side of the bearing, yet the load zone is on the bottom. This is poor bonding between the babbitt and backing.

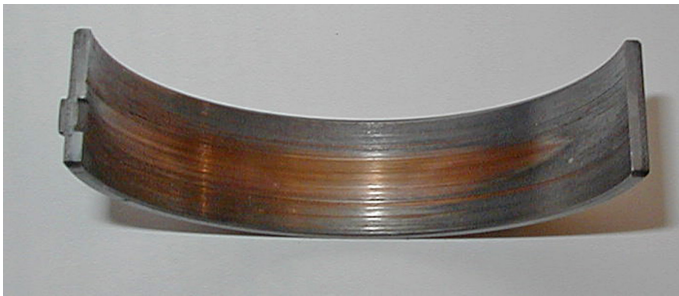
PHOTO 13.16 This is a trimetal insert from a gasoline engine. The center of the thin babbitt layer has worn through, showing the crankshaft journal running against it is barrel shaped.

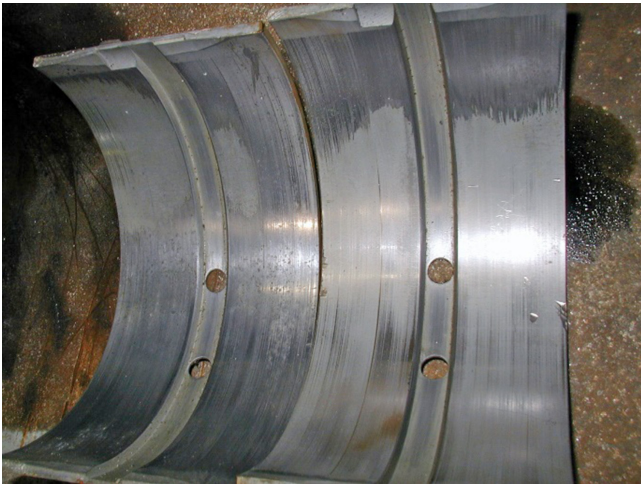
PHOTO 13.18 This is a pair of inserts from the main bearings of a 3000 kW (4000 hp) gas engine and the wear pattern shows serious misalignment. The engine was loose on the foundation and the looseness allowed the crankcase to distort.

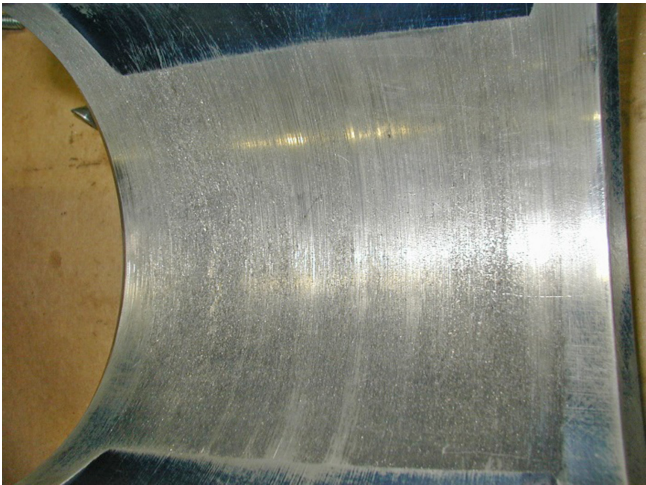
PHOTO 13.19 This is the bearing from a steam turbine and the sandblasted appearance is the result of static discharge from the dry steam. It was controlled by putting a grounding ring on the shaft. (The ring needs replacement about every five years.) We’ve seen similar damage on large motors.

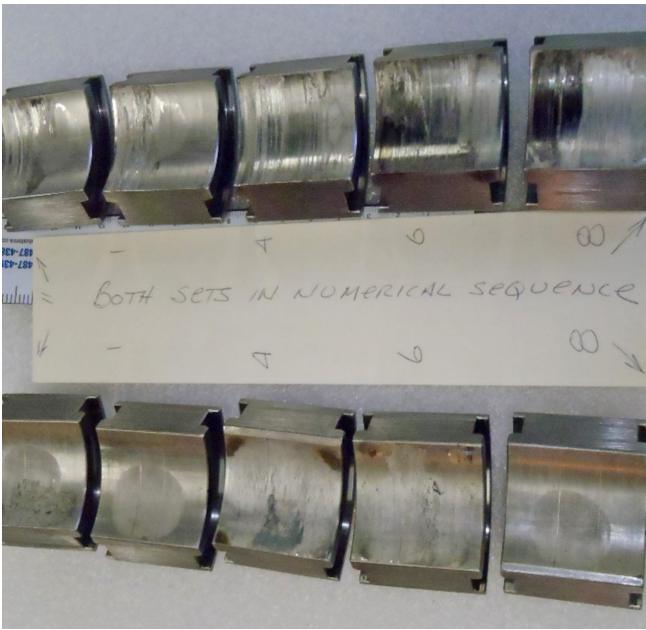
PHOTO 13.20 Two sets of tilting pad bearing inserts that show electrical discharge damage. As with the bearings discussed earlier, there are portions of the bearings that look as though they were sandblasted. These and the ones above were detected by oil analysis and the machines shut down before more serious damage occurred.

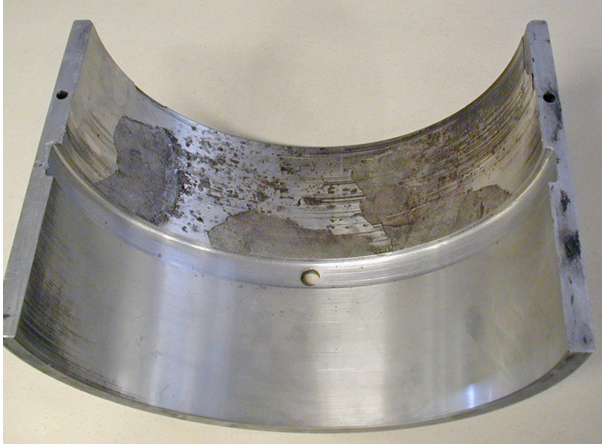
PHOTO 13.21 An insert out of an industrial compressor and the large areas cracked out on only one side clearly show this is an example of poor bonding in the manufacturing process. The black dots are patches of babbitt that have been heated and oxidized.

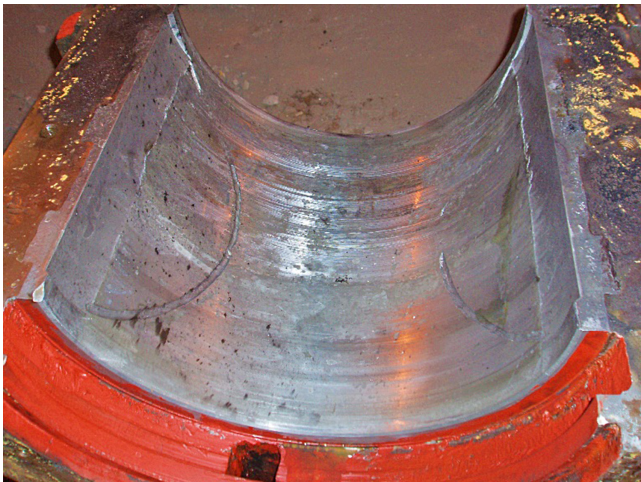
The photo below is of a very different failure cause. Plain bearings often have grooves or recesses to allow the oil or grease to be distributed across the entire face of the bearing. (Both 13.15 and 13.17 have grooves across the face while 13.18 and 13.21 have circumferential grooves to distribute the oil.) However, if those grooves are located in the high pressure load zone of the bearing, they allow the lubricant to escape (Photo 13.22).

PHOTO 13.22 This babbitt bearing shows a couple of problems. It was one of a series of failures but the damage on this was less than the others and provides a better example. There's a problem with misalignment, but equally serious are the grooves in the load zones that effectively allow the lubricant to escape to lower pressure areas and reduce the size of the bearing's load carrying area.

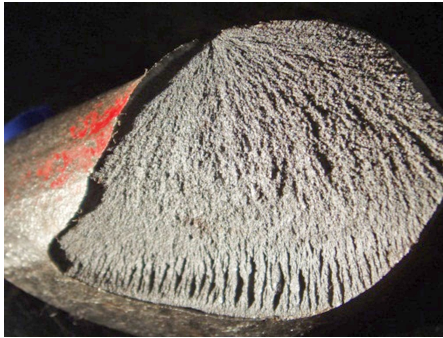
Chevron marks: Arrow-like indications on the surface of a brittle overload failure that point toward the initiation of the cracking. The photo to the right shows chevron marks clearly indicating the fracture origin on the side of a chainfall hook.
