PRACTICAL PLANT FAILURE ANALYSIS

A Guide to Understanding Machinery Deterioration
and Improving Equipment Reliability

Neville W. Sachs, P.E.

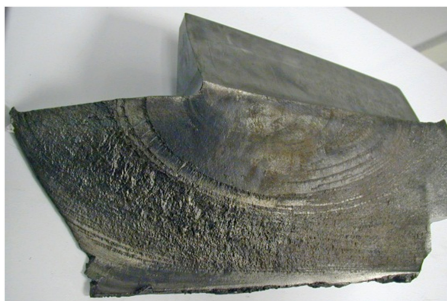
Progression marks: Sometimes called *beachmarks* or *stopmarks*, these are irregular lines across the surface of a fatigue fracture face that indicate how the crack grew across the face, however they do not appear when the magnitude of the fatigue force is consistent. Their interpretation aids in understanding the forces that caused the crack. (*Progression marks* occur when the crack growth slows or temporarily stops and are a manifestation of the crack tip plastic zone frequently discussed in fracture mechanics.) The *progression marks* on the fractured gear in the photo to the right show the crack started near the left side of the gear tooth and for the heavy contact to be on one side, the gear had to be badly misaligned.

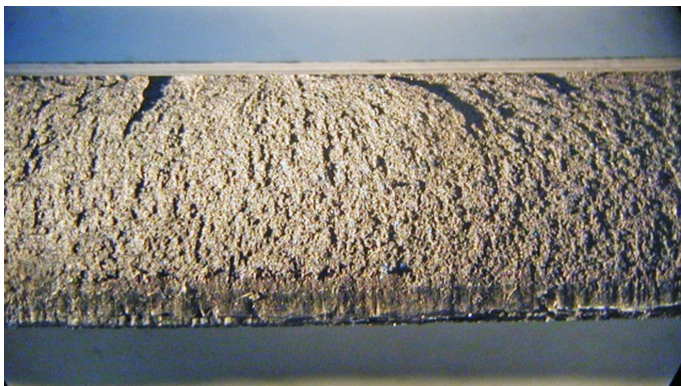
Ratchet marks: These are the boundaries between fractures that appear when adjacent fractures start in slightly different planes. As the fracture surface grows the two planes eventually unite, but before that the *ratchet mark* serves as divider between planes. The photo to the right shows a plate where the cracking starts on the top surface. In the center of the photo are two *ratchet marks* pointing in opposite directions. The initial crack was between them and later *secondary ratchet marks* appear farther right and left.

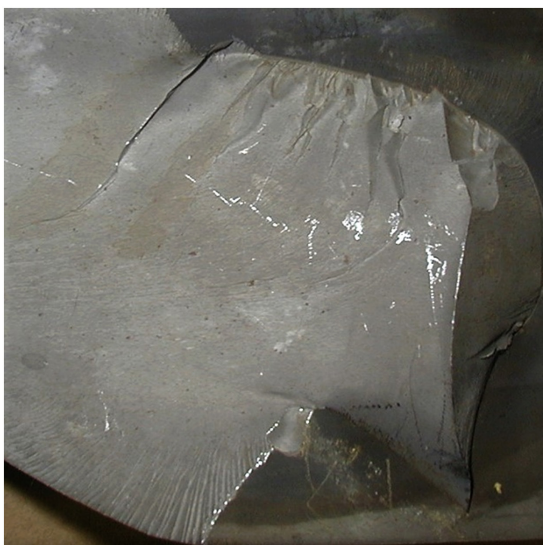
River marks: These are marks that often appear on a fracture face, but usually well away from the origin. They appear similar to what would be seen on a topographical map including the plot of a river and its tributaries and, similar to the river's flow, *river marks* show how the crack progressed. The photo to the right actually shows two sets of river marks. The ones at the top of the picture are relatively coarse and not often seen while those in the lower left are more typical. Both sets show a crack face that is growing from the top to the bottom of the piece.
